# Microsoft Surface Laptop 3 (13.5-inch) Teardown

Teardown of the Surface Laptop 2 performed on October 23, 2019.

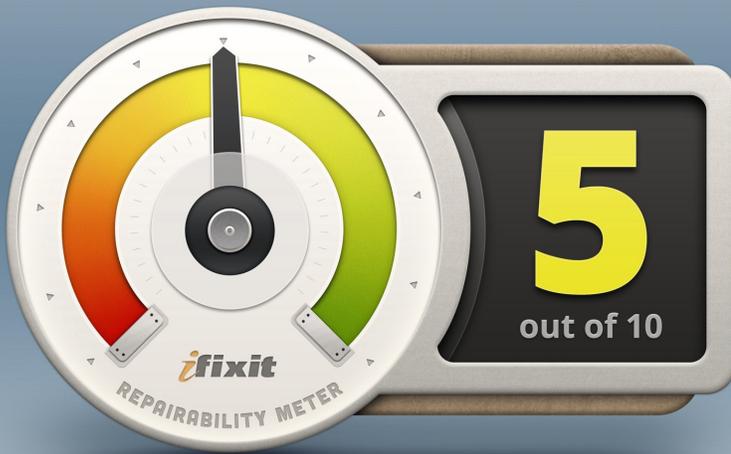
### REPAIRABILITY SCORE:

- The opening procedure is straightforward, with a clever design that represents a dramatic improvement over its predecessors.
- The M.2 SSD is fully modular and easy to access.
- Torx Plus screws call for relatively rare drivers, but our standard Torx drivers worked in a pinch.
- Display access is well-prioritized, but must be replaced as an (expensive) complete unit—subcomponents aren't modular.
- While many components are modular, intricate layered construction makes them difficult to service.
- The firmly glued-down battery will be very difficult to service when it inevitably goes kaput.
