Lenovo ThinkPad S540 Wi-Fi antenna cable Replacement

Fix poor or intermittend Wi-Fi connection Lenovo S540

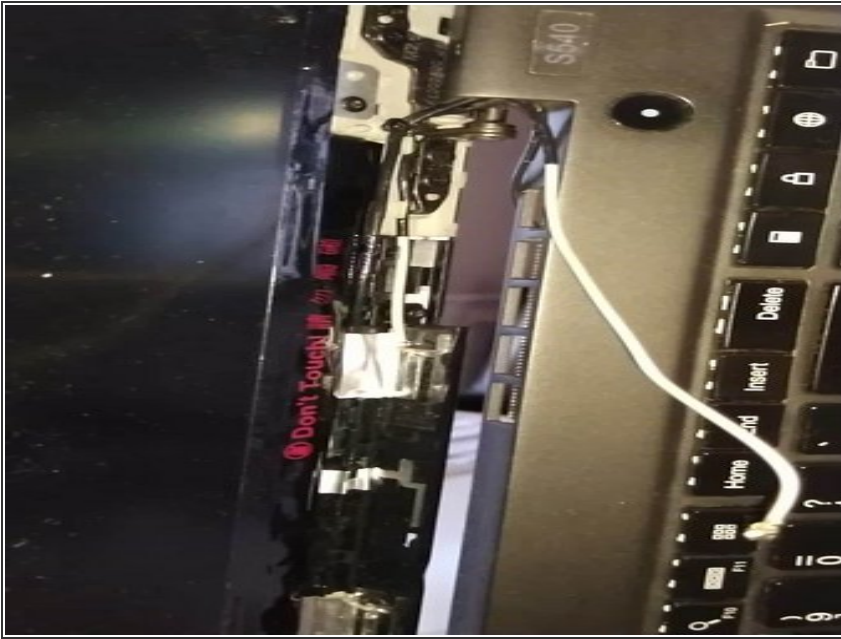
Step 4 — Diagnose the Wi-Fi antenna cable

- Carefully release the two Wi-Fi antenna cables from the Wi-Fi card
- Bring the two cables out to the same side as the LCD screen. In other words untangle them from the hinge
- Check if they are broken. There are two ways
 - Fingersnap the loose end of the cable to see if it flexes abnormally in a specific point, indicating a broken cable. In the video you can notice a specific point **just at the axel** where the cable flex much more than the rest of the cable
 - Connect an ohm-meter in the mini PCI-E end between the shield and the core. Start wiggle the cable
 - The resistance should always be zero, because of the antenna layout (An open-ended rectangle)
 - If the cable is trashy, the resistance will deviate from zero when the cable is being wiggled

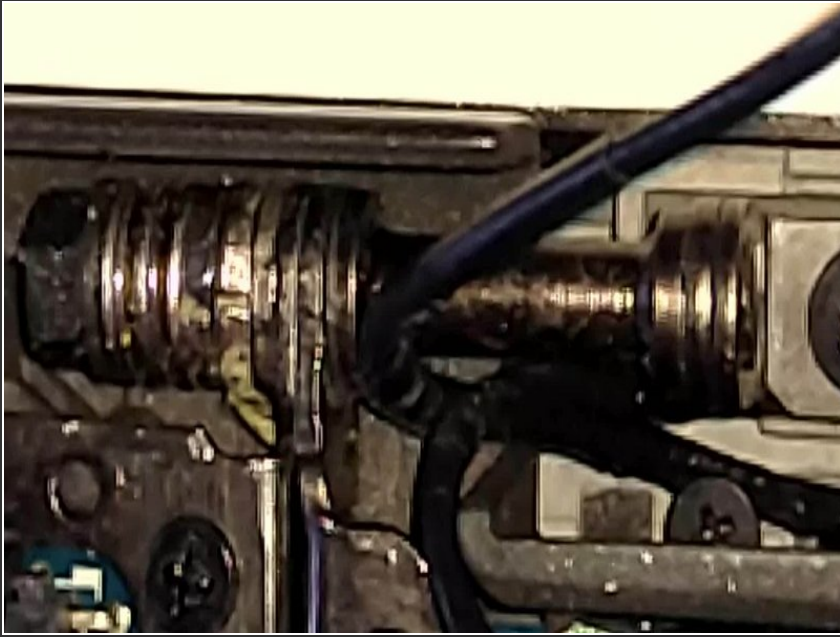
Step 5 — Here the cables gets proken

- This is most likely where it gets broken. The passage is narrow and sharp

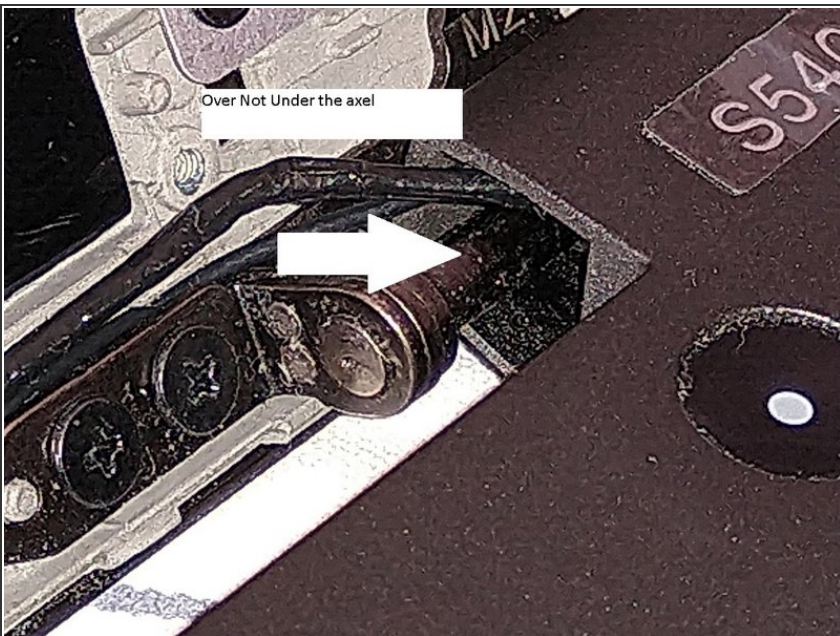
Step 6 — Replace the cable(s)

In my case it was the cable to connector “1” on the Wi-Fi card that was broken.

- After it is established which of the cables are broken, we have to replace them - Unsolder the old cable and remove it
- ***I decided to NOT cover the new cable in crymp-flex, to they can move more freely***
- Slide the new cable through the cable-guides near the hinge and drag it all the way through to the PCI-e connection to allow enough slack on the cable to solder it on

- Pre-solder the new cable and prepare the antenna solder area (remove the older soldering and add a small new lump of soldering). Note the **exact** location of the old antenna.
- Solder on the new cable to the antenna, shield first, then center core. it is **not** irrelevant where it goes. Pay attention not to heat the cable shield too much so it melts the insulator to the core wire. Use the location of the old antenna cable
- Retract the new cable through the cable guide
- Guide the Wi-Fi antenna cables around the hinge and into the PC it self
- I opted to route the cables the other side round the hinge than Lenovo originally did See the image
