1989-1995 Toyota SR5 Pickup Fuel Return Line Replacement

This guide will demonstrate the replacement of the pressure regulator fuel return line in the 1989-1995 Toyota SR5 Pickup.

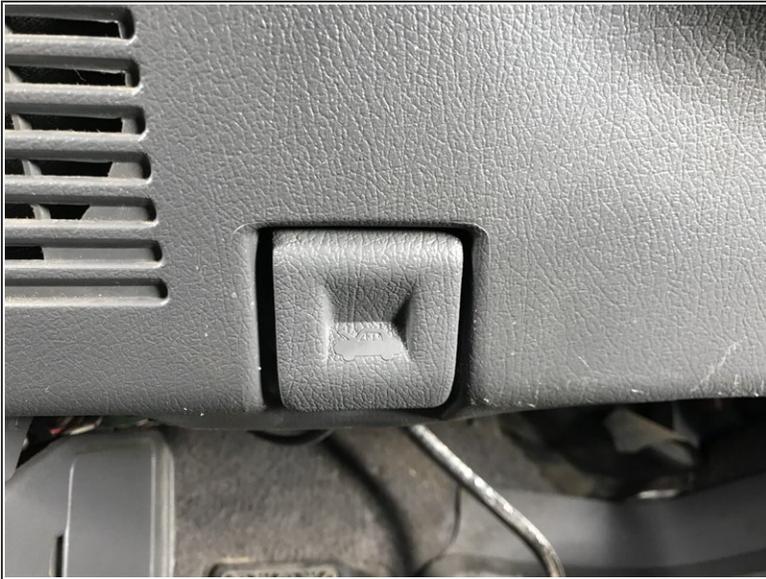
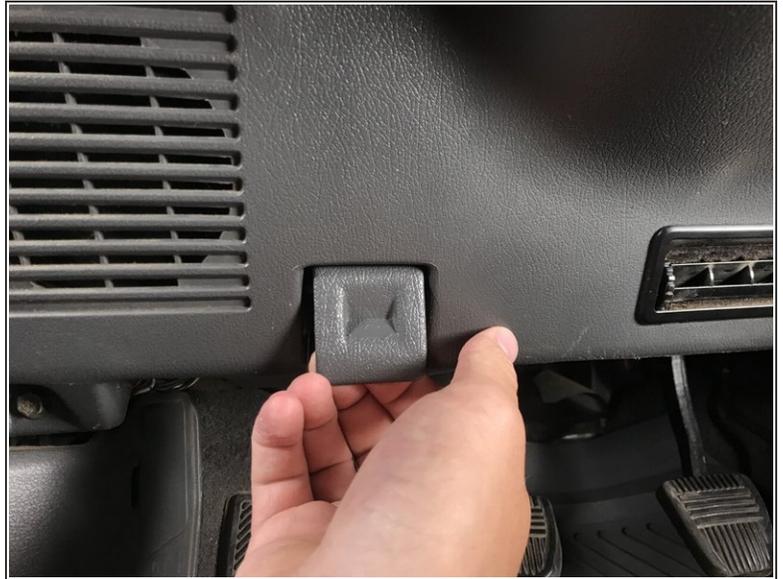
Step 1 — Pressure Regulator Fuel Return Line

- Pull the hood latch located underneath and left of the steering wheel until it unlatches. An audible "pop" will come from the hood when it has unlatched.

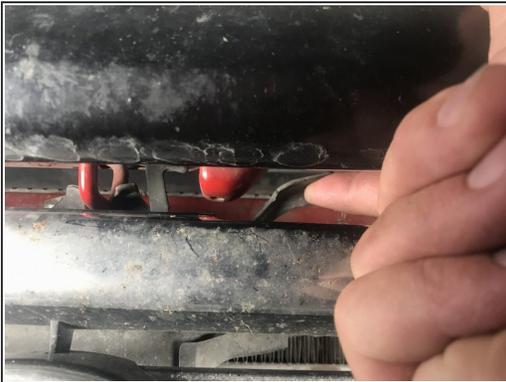
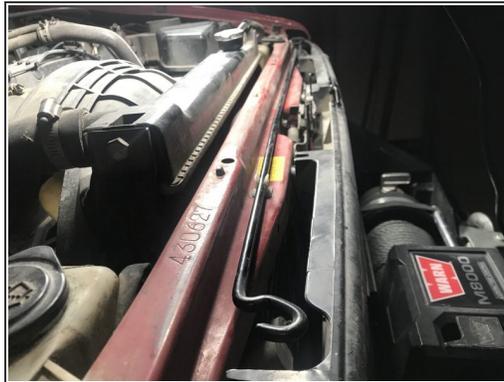
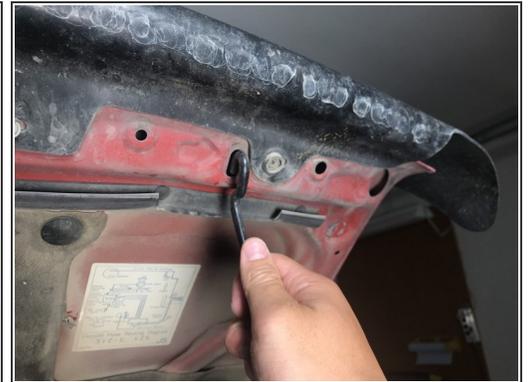
Step 2

- Now that the internal latch is opened, a latch underneath the hood must also be unlatched. Put your fingers underneath the hood and lift up on the latch above and right of the Toyota emblem.
- Remove the hooked end of the hood propping rod and allow it to pivot at the driver's side; place the hooked end in its receptacle to prop the hood.

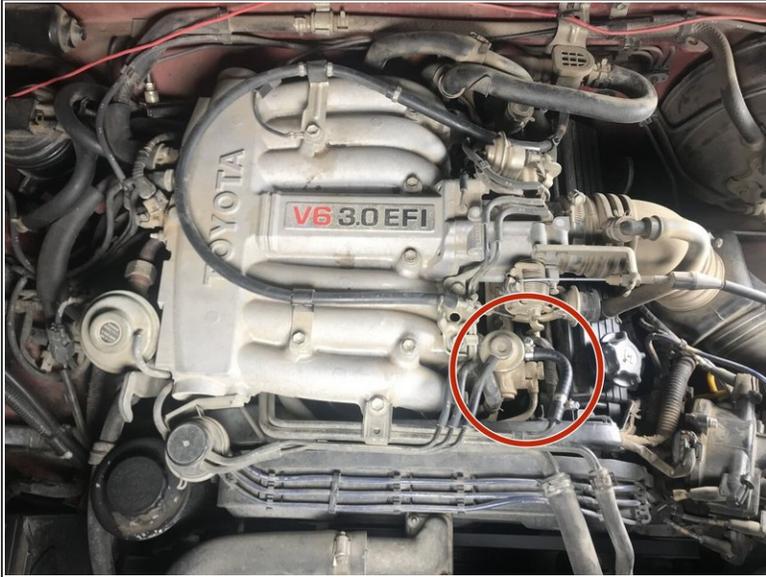
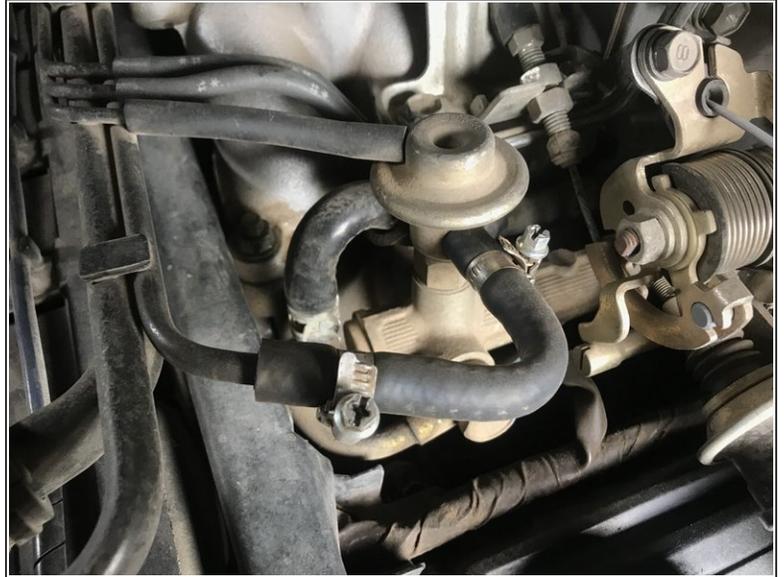
Step 3

- Inspect the line for damage such as cracks, holes, and fuel seeps.
- ⓘ Continue the repair if it shows signs of these failures. Otherwise, the fuel leak is coming from elsewhere.
