# Repairing Mercedes W123 Door Lock Master Vacuum Switch

When diagnosing your vacuum system you may find you master vacuum switch in the driver's door is leaking vacuum. If so, consider repairing it using this guide before springing for a pricey replacement!

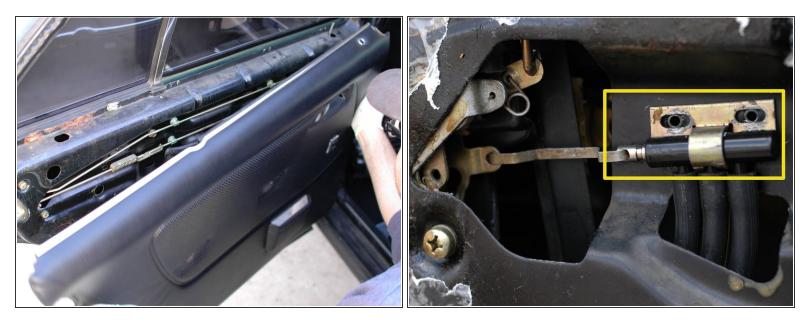
#### Step 1 — Repairing Mercedes W123 Door Lock Master Vacuum Switch

- To begin you will need to remove your door panel. For help with this process see the door panel removal guide.
- Then you will need to remove the master door lock switch from the car. After following the steps in the <u>vacuum door lock system diagnosis technique guide</u> to unbolt the switch from the door and disconnect it from the lock mechanism simply pull the three vacuum lines, making note of where the red, green, and solid yellow lines attach.

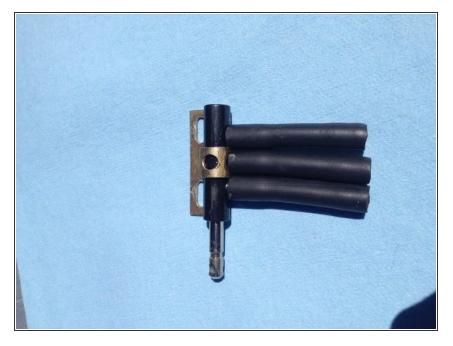
Shown is the vacuum switch removed from the door, with the flexible rubber vacuum connectors still attached. The rubber vacuum connectors may also be left on the plastic hard lines in the door, its your choice.

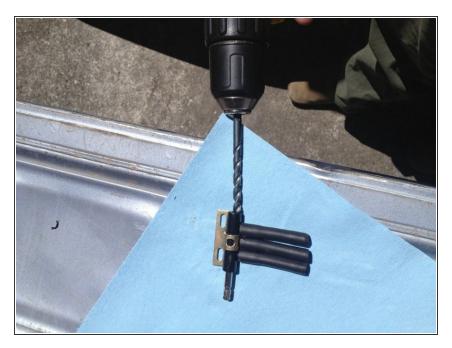
#### Step 3

- The metal shaft of the lock switch needs to be removed. To remove the shaft, drill in to the back of the switch body with a 5/16" drill bit.
- Be sure to drill as centered on the body as possible and as straight as possible. Go slowly and be careful to stop drilling after you have gotten through the plastic body of the switch. To help avoid damaging the piston shaft pull it as far out as possible away from the area to be drilled.

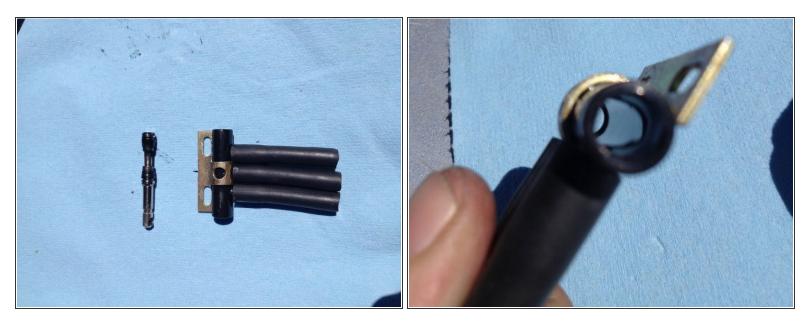
- Once the back of the switch is drilled out the piston shaft can be removed.
- The switch body is otherwise hollow.
- The black rubber seals you can see on the switch are what seal that piston inside the switch body.

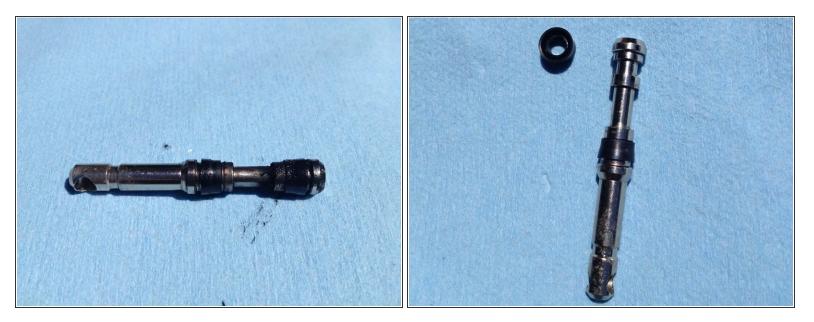
- Inspect the shaft closely. As you can see here there is sufficient dirt and other contaminants to prevent a good seal, hence the leak.
- Clean the piston shaft, then carefully remove the two rubber seals with a small flat blade screw driver or pick to clean underneath.
- Re-install the seals on the shaft.
- Lubricate the shaft with a silicone grease that is safe on rubber.

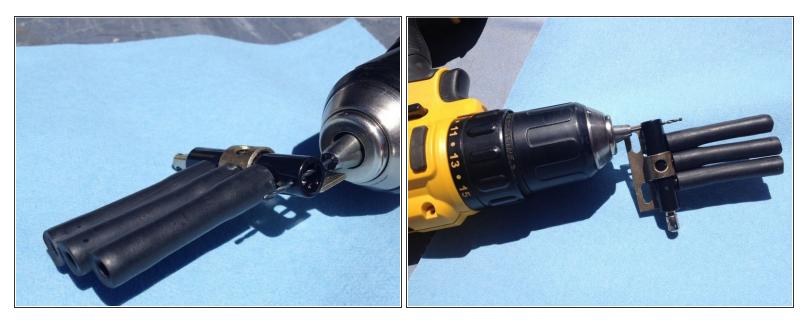
- Re-insert the piston shaft in the body of the switch.
- Use a drill with a 1/16" bit to drill a small hole from top through to the bottom of the switch body at the very back of the body, on the opposite side of the piston shaft.

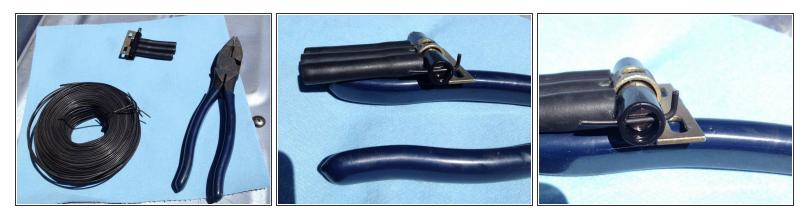
- Cut a small section of wire, smaller than 1/16" in diameter, and insert it in the hole you just drilled at the back of the switch body.
- Bend the top and bottom of this wire so it stays in the opening.
- This will keep the shaft inside the body. Keep in mind that it's OK to leave the back of the switch open; the two rubber seals on the shaft are what retain the vacuum inside the switch.
- An alternative would be to find a cotter pin of suitable size to fit in this hole.

After the modification is complete, re-install the switch in the driver's door. Test your vacuum system.
