Repairing a Panasonic SA-HT810V with the H02/H07 error

This guide describes how to fix the H02/H07 error that is common with Panasonic DVD/VCR players.

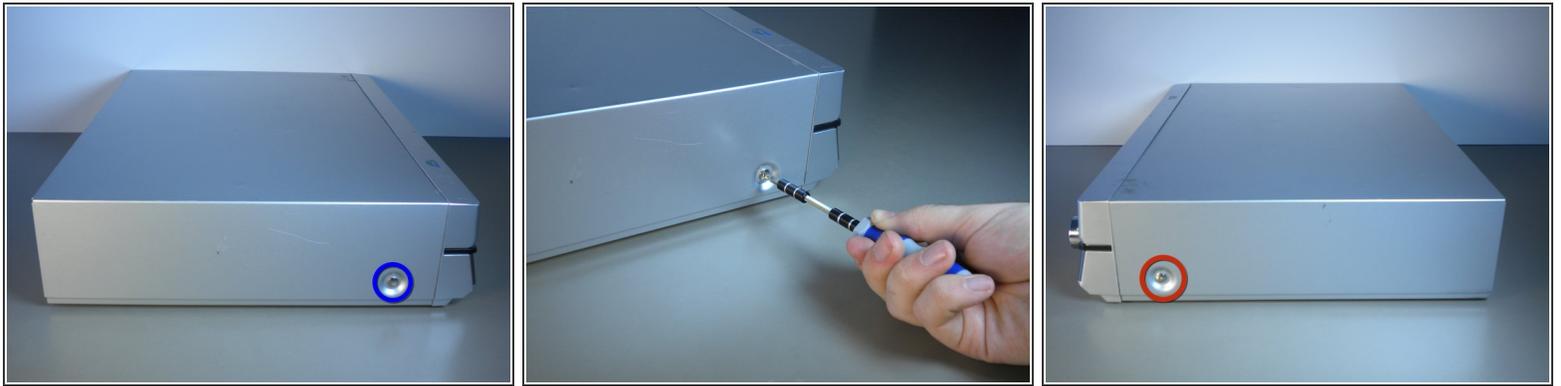
Step 1 — Repairing a Panasonic SA-HT810V with the H02/H07 error

- With the front display of the device facing you, rotate the device 90 degrees counter clockwise.
- Remove the screw that is on the right side of the panel facing you.
- Now rotate the device 180 degrees and remove the second screw.
 - Remove all screws with a phillips head screwdriver.

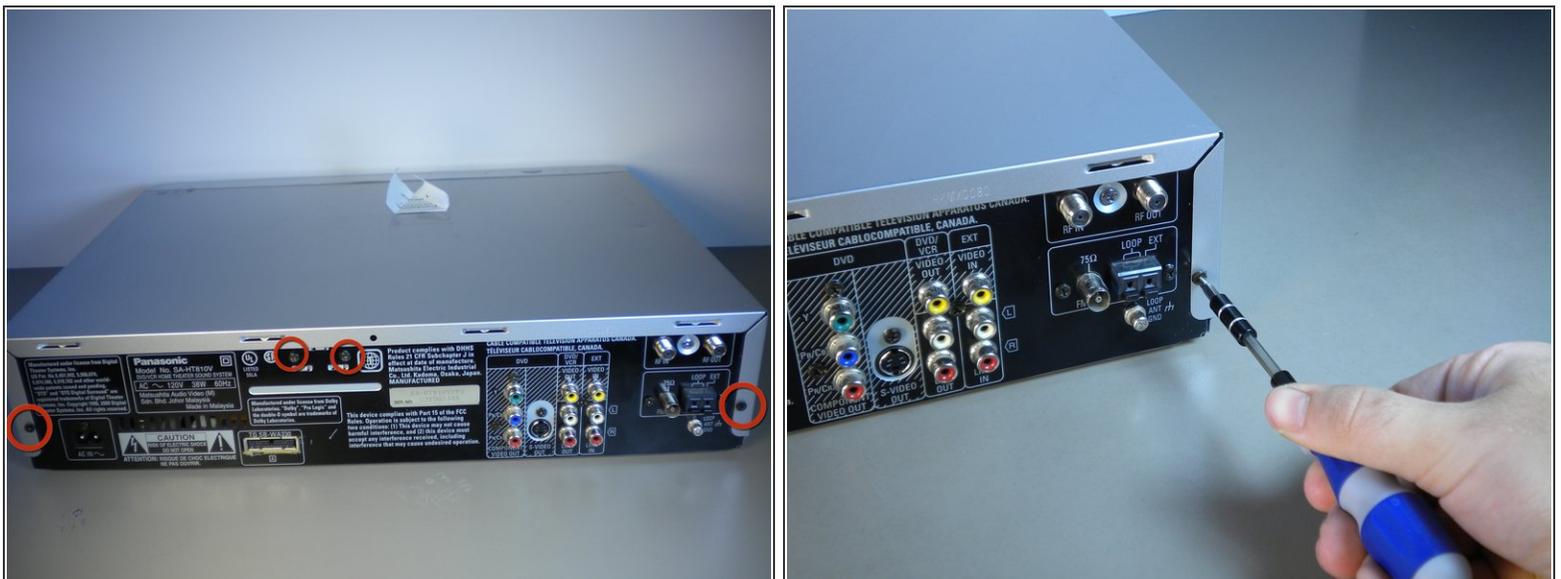
Step 2

- Rotate the device so that the back faces you.
- With a phillips head screwdriver, locate and remove the two screws highlighted by the red circles in image one.

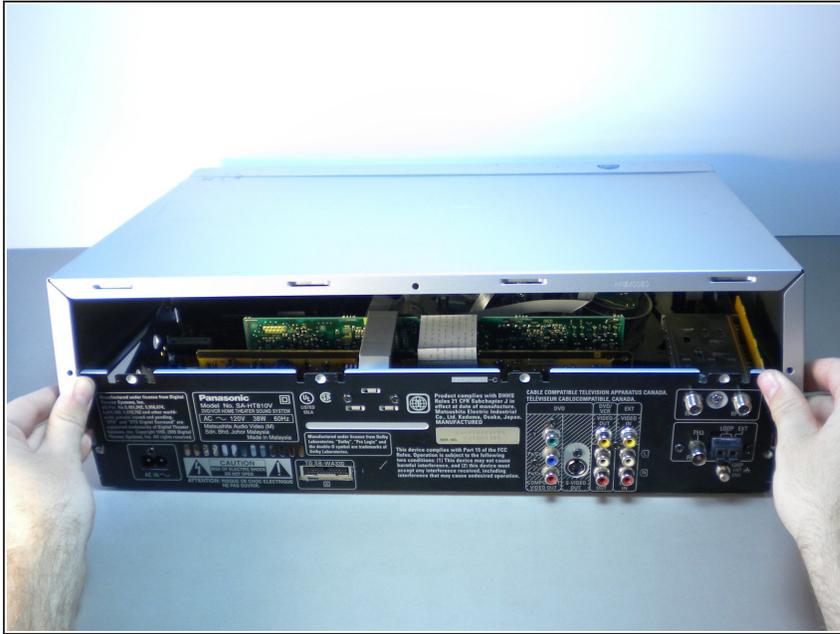
Step 3

- Before removing top cover make sure that the back of the device is facing you.
- Remove the top cover by bending out on the sides, and pulling the cover towards you while applying upward pressure.

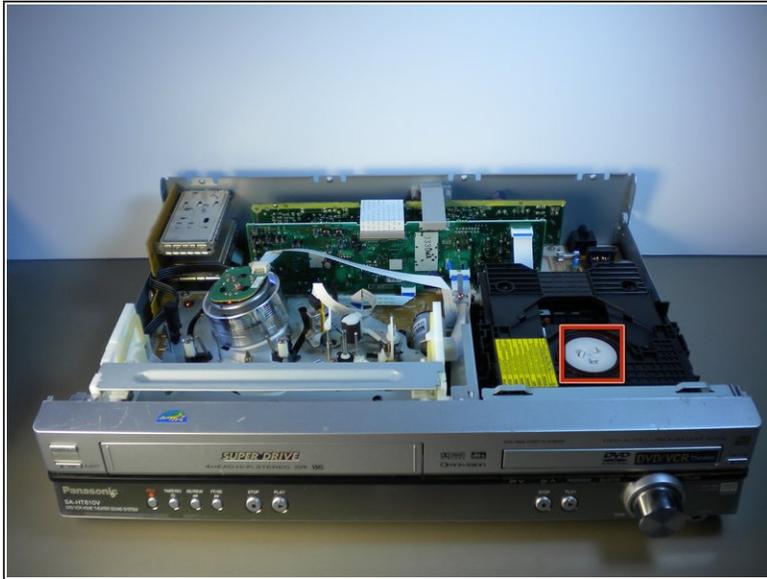
Step 4

- i** Note that the spindle you will be lubing is located underneath the white disk device highlighted in figure one
- Tilt the device on its front side until you can see underneath the white circular component mentioned in the note above.
 - Locate the spindle circled in figure two and apply one or two drops of 3 in 1 lubricating oil to the spindle.

To reassemble your device, follow these instructions in reverse order.
