Sony Ericsson xPeria Active Headphone Jack Replacement

This guide will walk you through the steps to replace a faulty heaphone jack on your Sony Ericsson Xperia Active cellphone.

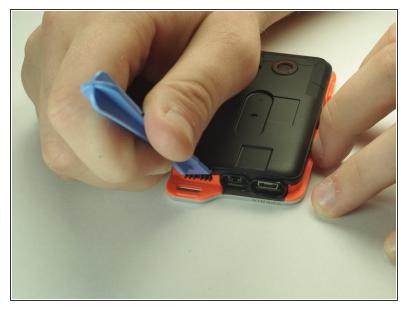
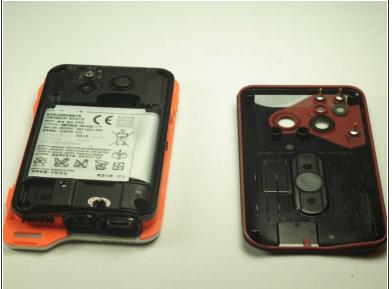
Step 2 — Remove inside plastic battery cover.

Remove the battery shield with the plastic opening device.

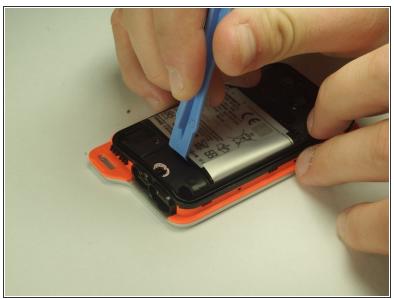
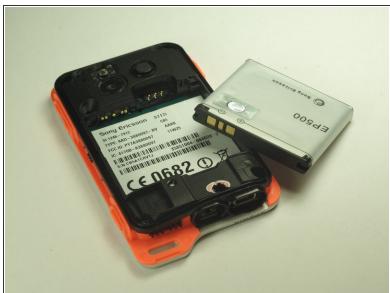
Step 3 — Remove the battery

Remove the battery.

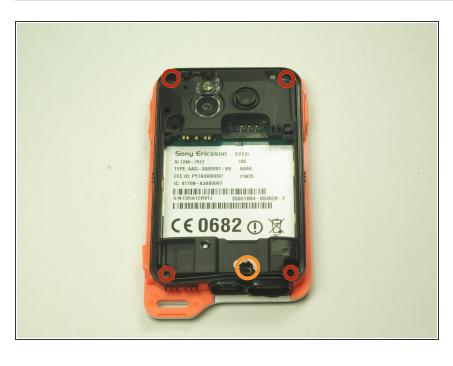
Step 4 — **Unfastening The Motherboard Cover**

- Unscrew the 5mm screws with the T5 head.
- Unscrew the 6mm screw with the T6 head.

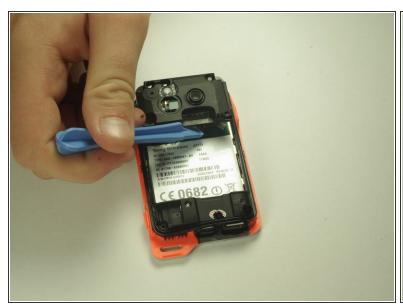
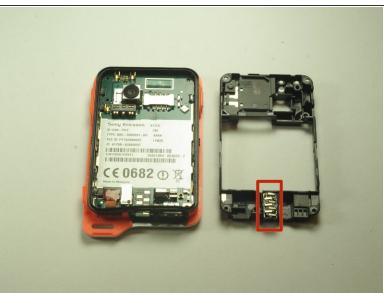
Step 5 — Removing The Motherboard Cover

- Remove the black cover with the plastic opening tool.
- Remove the headphone jack from its slot.
