Kenmore 400 Washer clutch band Replacement

Here is a Kenmore 400 model 11029422801 with a clutch that was slipping. The washer went through all the programs but left the laundry soaking wet after the spin cycle. It sounded like it was spinning, but when we checked the drum while spinning, we noticed that it was not achieving full spinning speed. This was most evident on heavy loads.

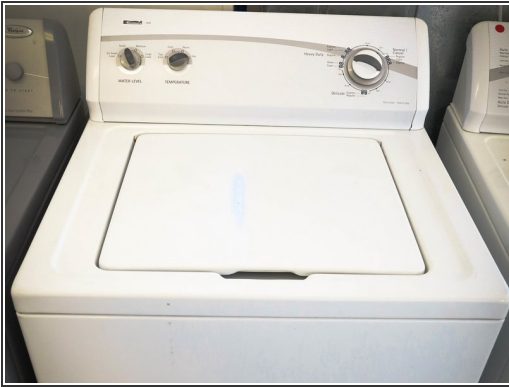
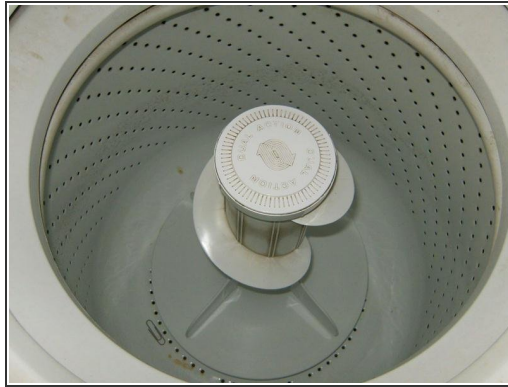
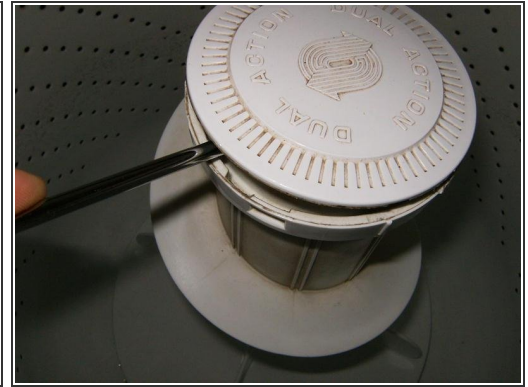
Step 1 — Clutch band

- Kenmore 400 washer that has difficulty spinning. It runs through the cycle but does not spin properly.
- Open the lid
- Remove cap from the agitator by using a flat tip screwdriver or similar.

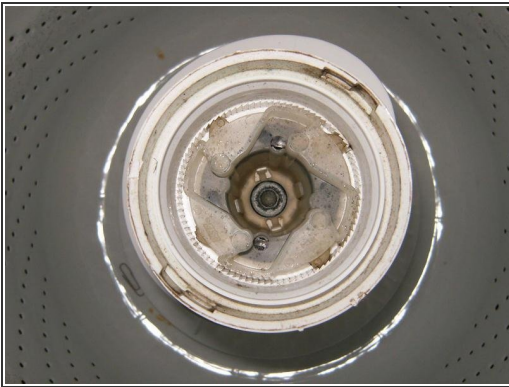
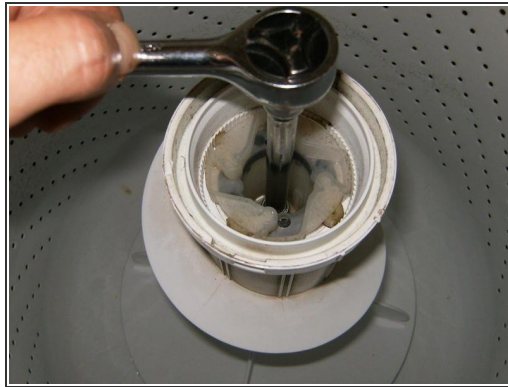
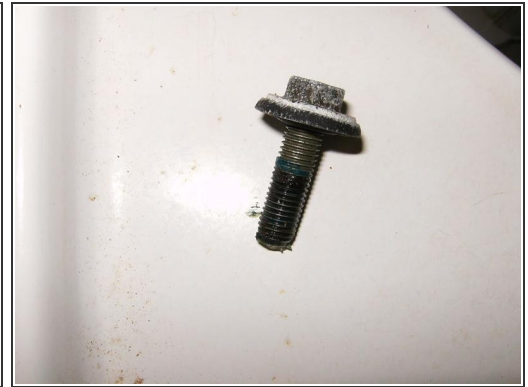
Step 2

- With the cap removed, a 7/16 hex bolt becomes visible.
- Use a socket wrench with 4 inch extension to remove the bolt.
- The agitator bolt measures 5/16 X 1 inches, 24 thread size

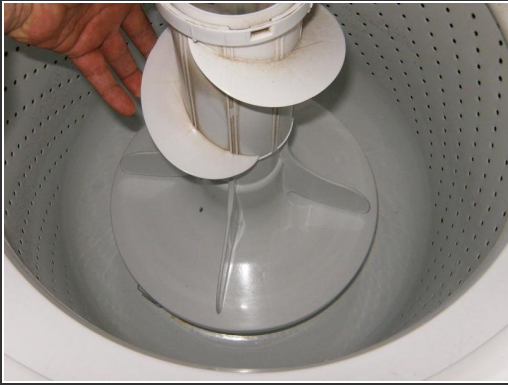
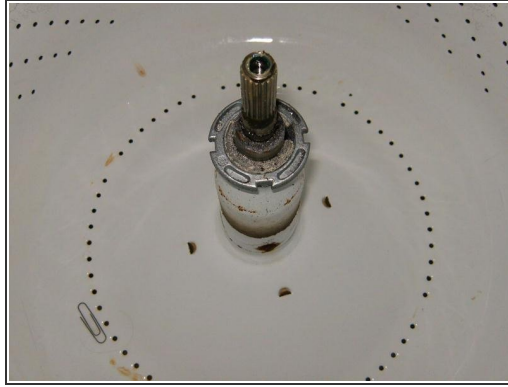
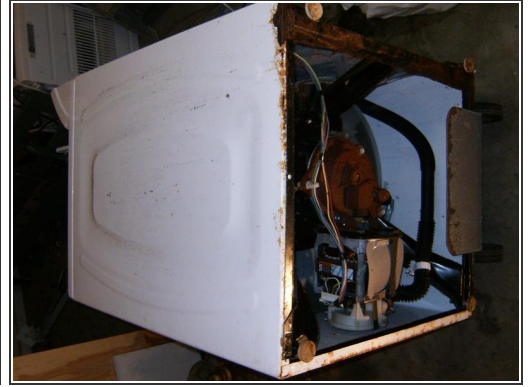
Step 3

- With the bolt removed, pull the agitator of the shaft.
- View of the drum with agitator removed
- For ease of working on the bottom parts, lay the washer on its side.

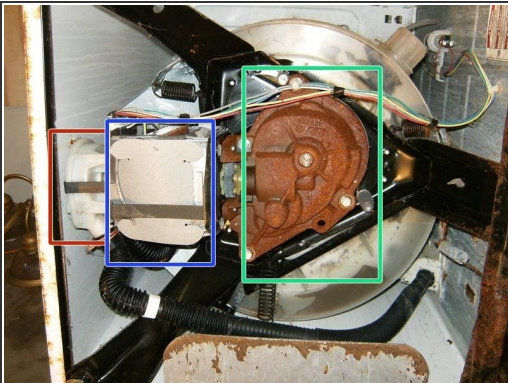
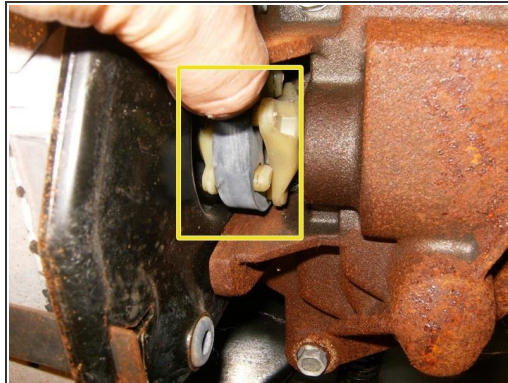
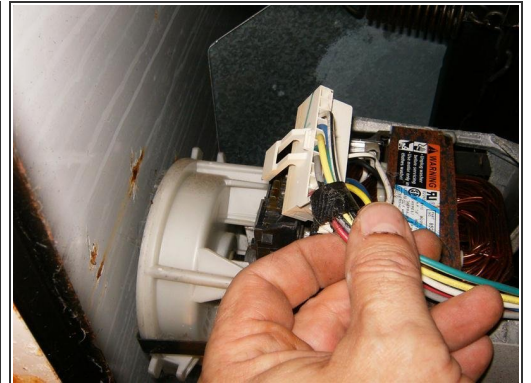
Step 4

- Main parts of the assembly include
 - Drain pump
 - Motor
 - Transmission
- This is a direct drive model. No belts but a motor coupler connects the motor to transmission. Check for any cracks etc.
- Remove the wiring harness from the motor

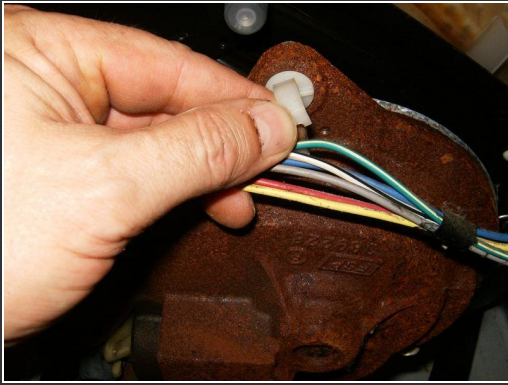
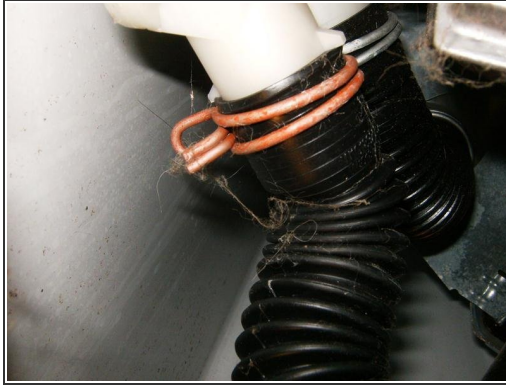
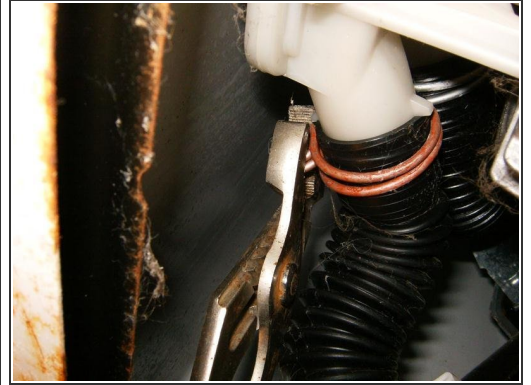
Step 5

- Remove the wiring harness from the clip on the transmission
- Drain lines from the drum and drain hose are connected to the pump with spring clamps.
- Using a pair of pliers and squeezing the opposite ends of the clamps together will loosen the clamp.

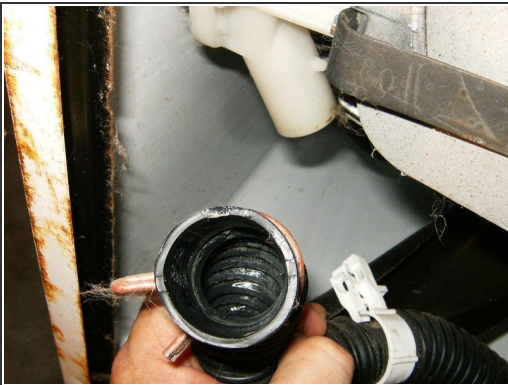
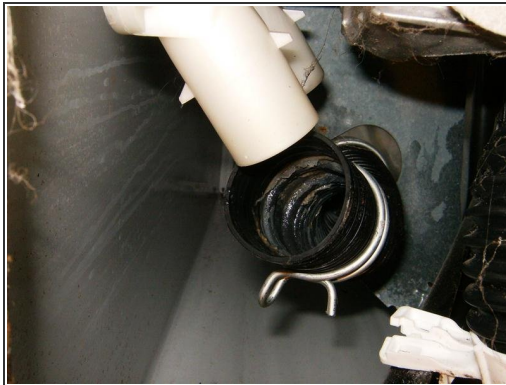
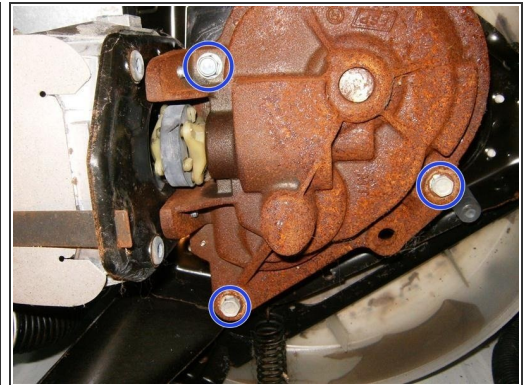
Step 6

- Pull the drain hose of the pump
- Remove the tub-to-pump hose the same way
- Remove the three 1/2inch bolts.

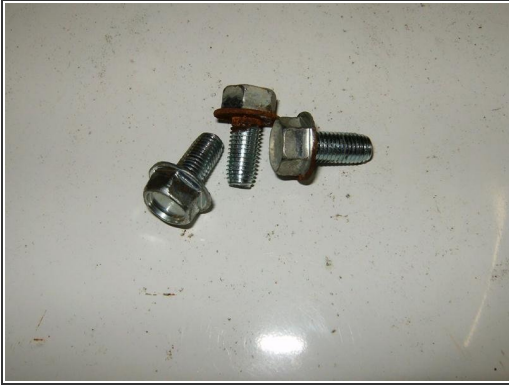
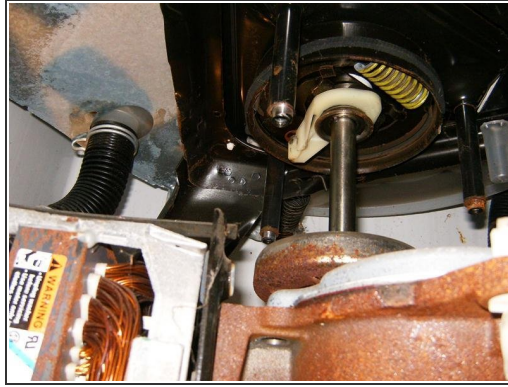
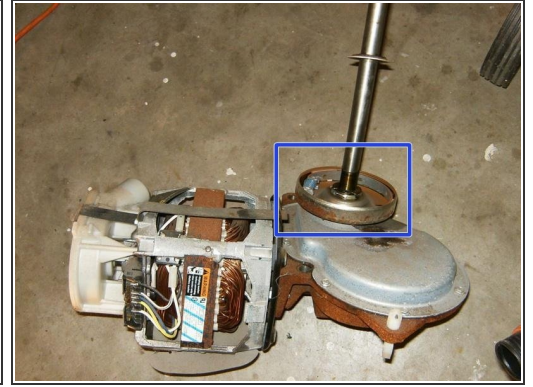
Step 7

- Here are the three bolts. They are 5/16 by 11/16 with a 1/2 inch hex head.
- With the three bolts removed, pull the complete assembly out of the drum
- With the assembly removed, the clutch is now completely visible.

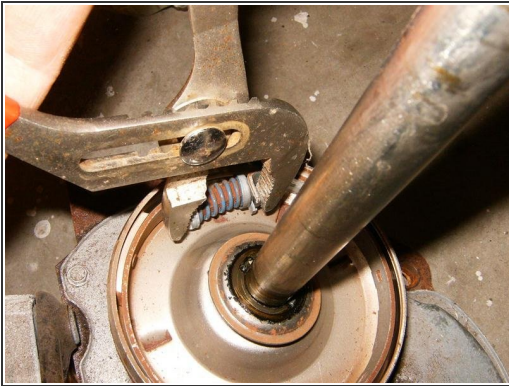
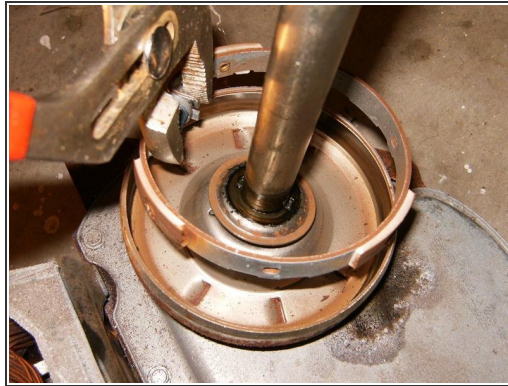
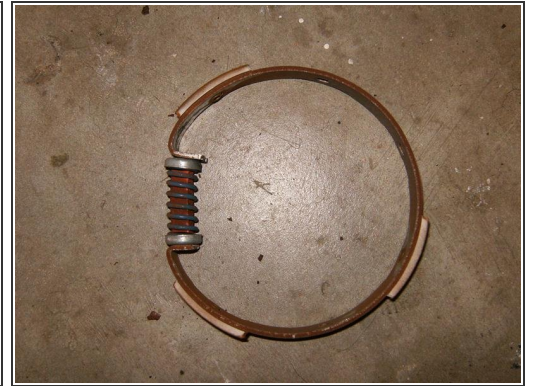
Step 8

- It is not necessary to replace the whole clutch. For this repair only the clutch band needs to be replaced
- Using a pair of pliers to compress the spring will loosen the clutch band.
- Lift the clutch band out of the clutch housing
- Clutch band removed. Replace with model specific part.

To reassemble your device, follow these instructions in reverse order.
