Insignia NS-CLIP02 Keypad Replacement

If your Insignia NS-CLIP02 has a keypad that does not work, use this guide to replace the motherboard inside. Faulty motherboards cause the keypad to malfunction, so replacing it should cause the keypad to work again.

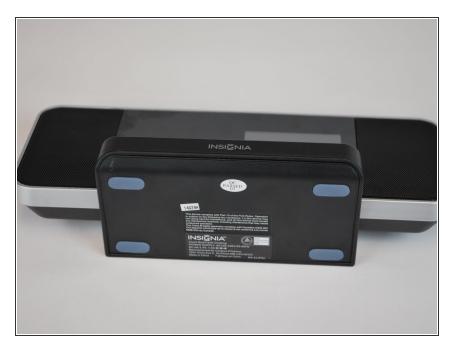
Step 1 — Keypad

Locate the bottom of the device.

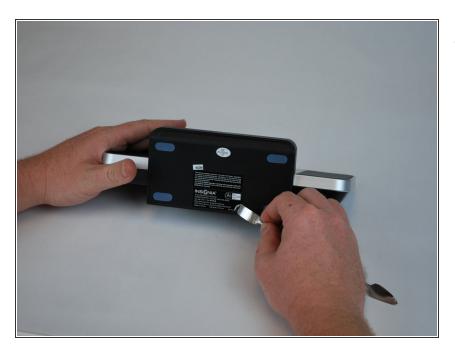
Step 2

Begin by using a metal spudger to peel back the adhesive sticker and locate the 11mm screw beneath the sticker.

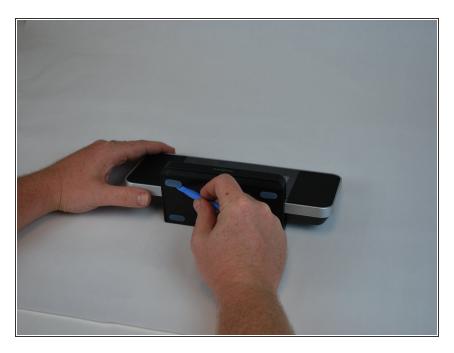
Step 4

Using a plastic spudger, peel off the adhesive gel stoppers.

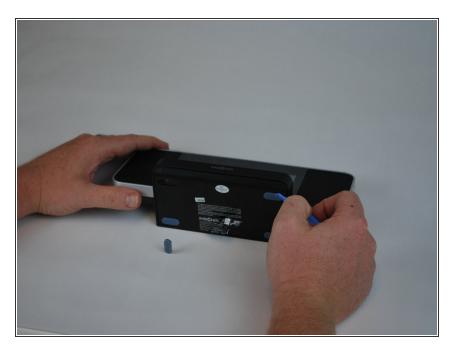
Continue peeling the rest of the gel stoppers from the bottom of the device.

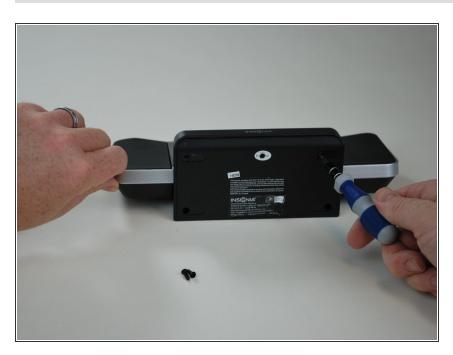
Step 6

Begin unscrewing the six 11mm screws with a Phillips head screw driver.

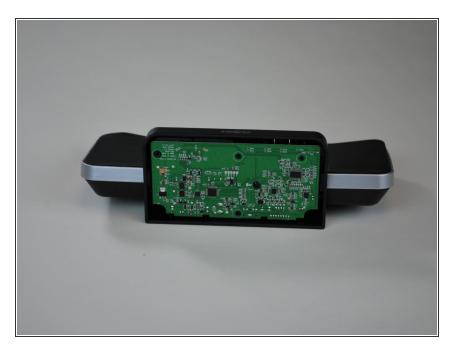
Once you peel off the bottom from the device, you will see the motherboard.

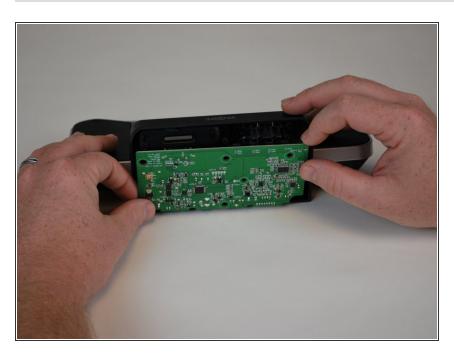
Lift the motherboard from the device.

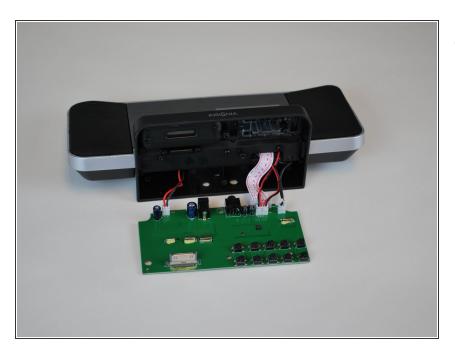
Step 10

Locate the four plugs connecting the motherboard to the rest of the device.

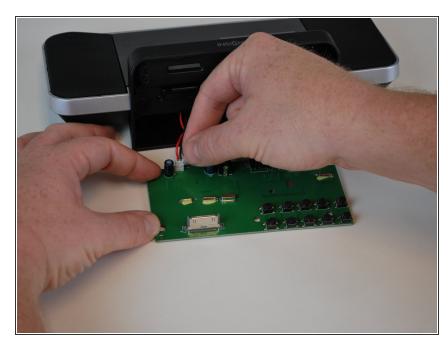
Begin with removing the plug to your left.

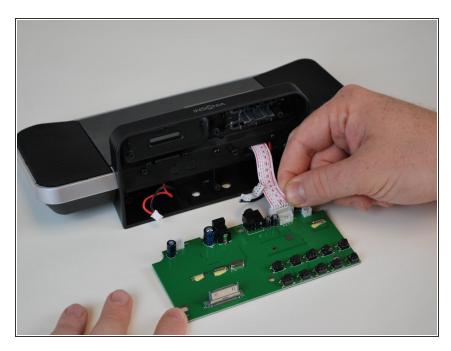
Remove the LCD screen plug last.
 Then, follow the following instructions in reverse, replacing the old motherboard with the new one to fix the keypad.
