# Amazon Fire 5th Generation Rear Camera Replacement

Use this guide to replace the rear-facing camera of the Amazon Fire 5th Generation.

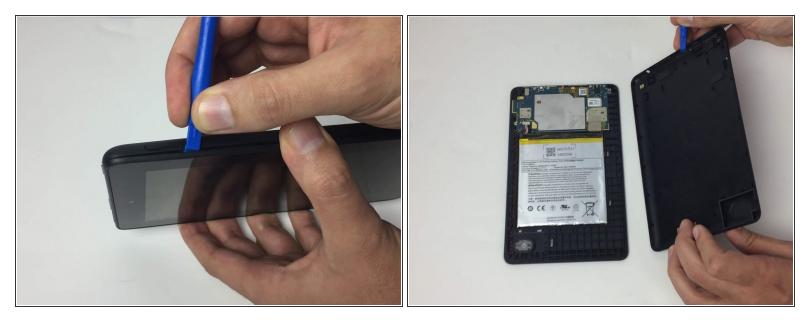
#### Step 1 — Speaker

#### (i) Ensure that your device is turned off.

- Remove any micro-SD card that may be installed in the Fire. Failure to do so could damage the micro-SD card itself or the micro-SD card reader on the Fire.
- While holding the device firmly, wedge the iFixit Opening Tool into the crease along the outer edge of the device (as shown in the image).
- Slowly, grind the iFixit Opening Tool into the crease along the outer edges of the device until the entire back cover loosens.
- Then, remove the back cover from the device.

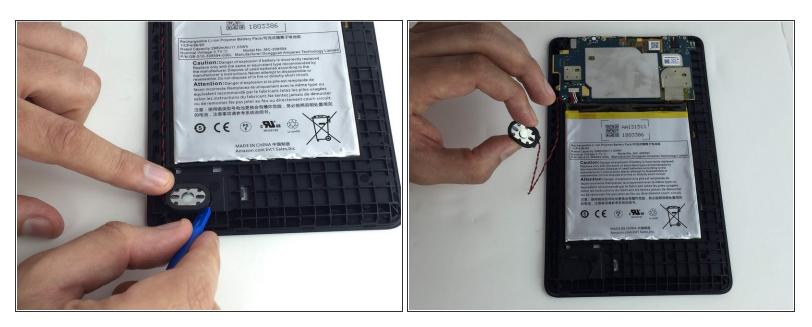
- Pry the speaker from the case using the iFixit Opening Tool.
- Lift the speaker up from the device to remove the speaker wires from their groove in the case.

A Be careful not to pull the speaker wires from the motherboard.

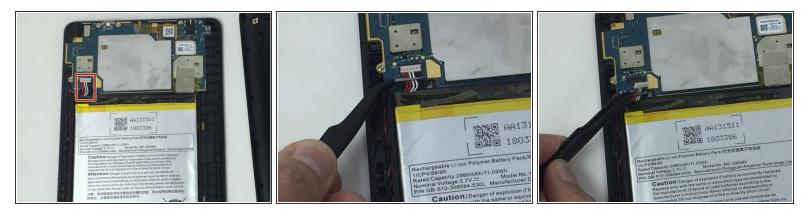
#### Step 4 — Motherboard

- The battery connector is located in the upper left corner of the Amazon Fire battery pack.
- To disconnect the battery connector, use angled ESD precision tweezers to lift the cables up and out of their socket.
- Make sure you pull the battery connector cables themselves out and not the actual socket. Doing this step incorrectly could result in breaking the connector entirely.

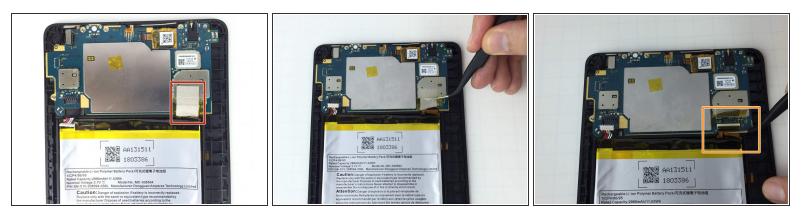
- The LCD- Motherboard connector cable has a protective overlay that you must peel back with precision tweezers in order to expose the actual connector.
- Gently pull down on the connector cable using precision tweezers in order to disconnect the cable.

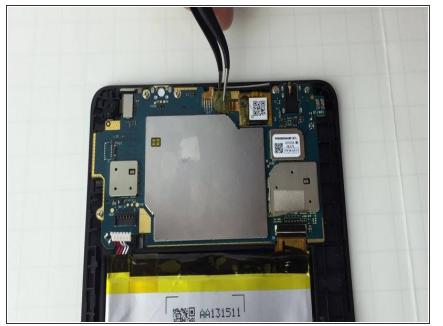
#### Step 7

- The LCD Digitizer on the Amazon Fire tablet has a locking cable connector that holds it in place on the motherboard.
- To remove the cable, use the iFixit
  Opening Tool to unlock the LCD
  Digitizer cable connector.
- Once the wire connector is removed, use the iFixit Opening Tool to pry the entire LCD Digitizer away from the motherboard.
- (i) Remove any tape that may be covering the connector.

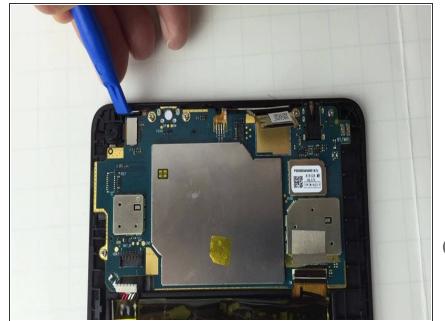
- The volume and power buttons must both be repositioned in order to remove the motherboard.
- To reposition the power and volume buttons, use the iFixit Opening Tool to pull the plastic casing upwards. Then, remove the casing completely.
- (i) Make sure that both the volume and the power buttons are free from the plastic casing before separating the motherboard from its case.
- Be very careful when repositioning the volume buttons, since the fragile digitizer ribbon cable runs from the motherboard to the digitizer right next to the volume buttons. It is very easy to damage the ribbon cable while working in this area.

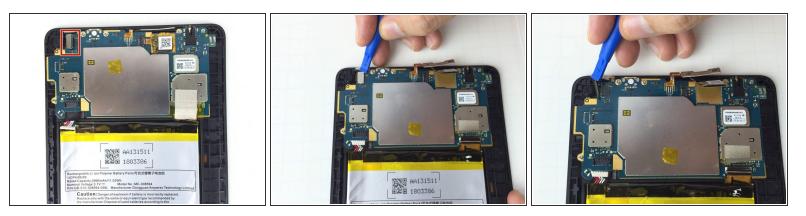
- The rear facing camera wire connector must be disconnected in order to remove the motherboard.
- To remove the rear facing wire connector, insert the iFixit Opening Tool beneath the connector and wedge it upwards.

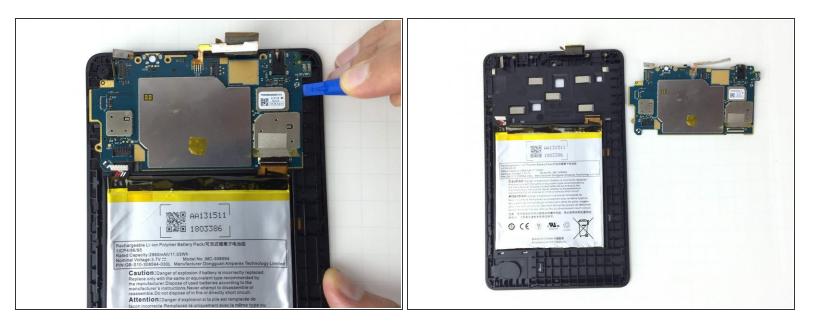
# Step 10

• Position the iFixit Opening Tool beneath the motherboard and pull upwards to remove the motherboard from its case.

Please handle the motherboard with gloves because skin oils can damage the connections on the board.
