# Acer One 10 S1003-19GY Rear/Front Camera Replacement

Replace front or rear camera for Acer One 10 S1003-19GY.

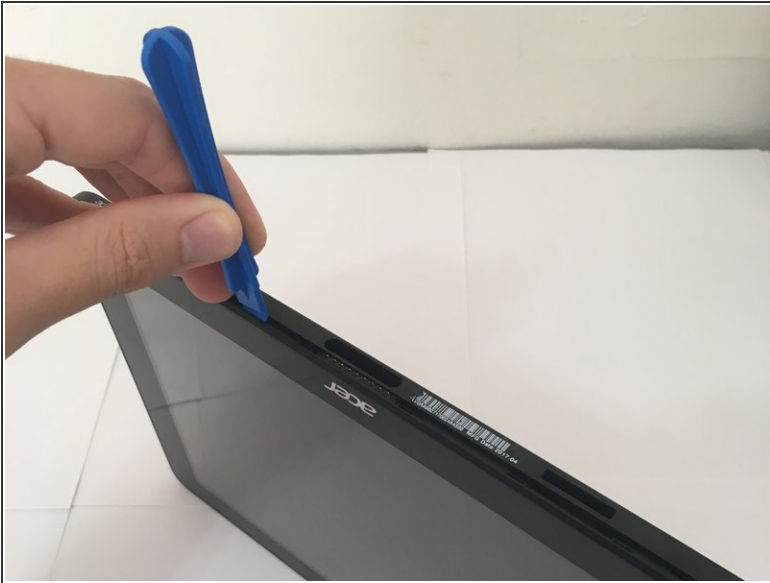
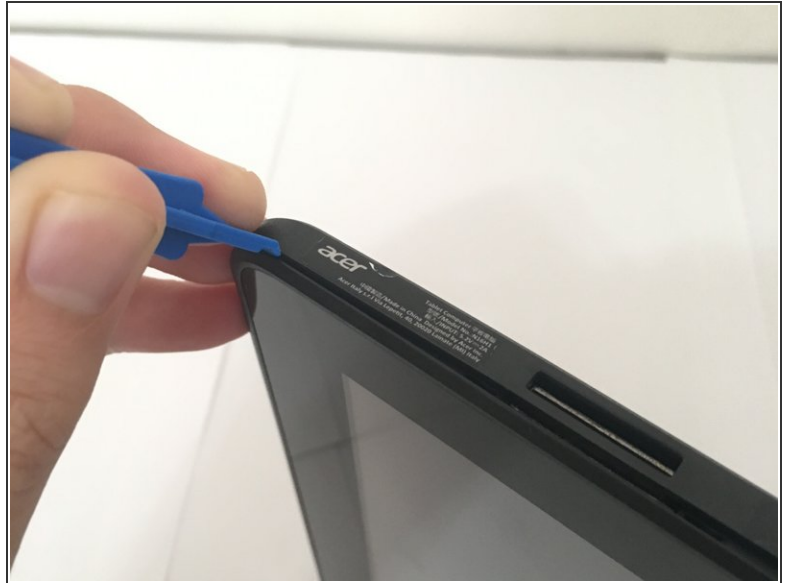
## Step 1 — Back Panel

- Power off the device and make sure it is disconnected from any external devices.
- Use a plastic opening tool to create a gap between the front and back casing of the device.
- Slowly maneuver the plastic tool around the entire perimeter of the tablet to separate the front and back.

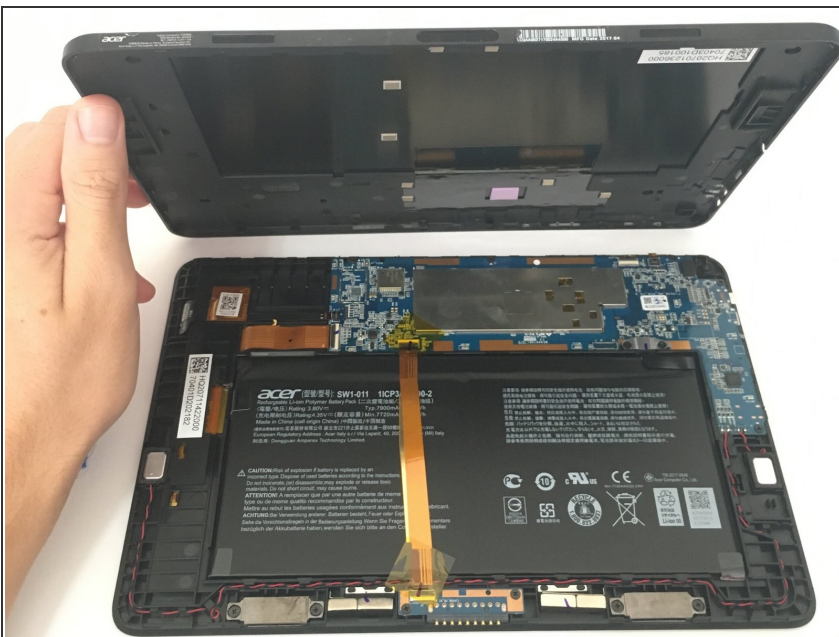
## Step 2

- Set the device screen side down and remove the back casing.
