Keurig B70 Platinum Brewer Handle Replacement

Replace the brewer handle on your Keurig B70 Platinum if you encounter any problems with it.

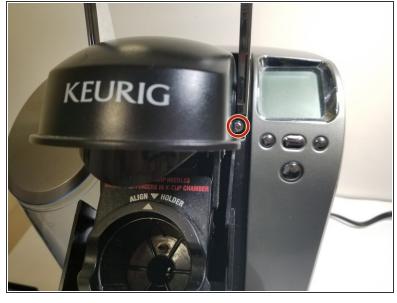
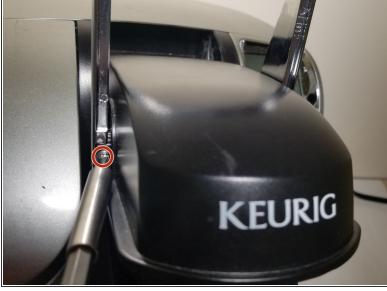
Step 2

• Using a T15 Torx screwdriver, remove the two 29.0 mm screws on each ends of the handle.

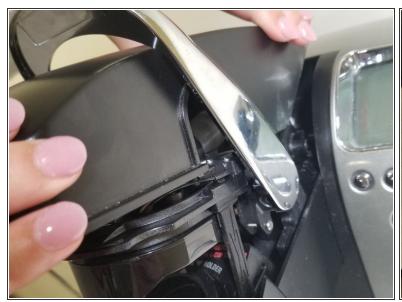
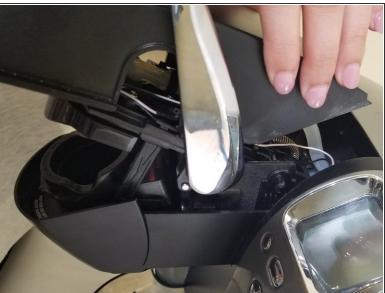
Step 3

Lift and pull the black plastic cover away from the Keurig.

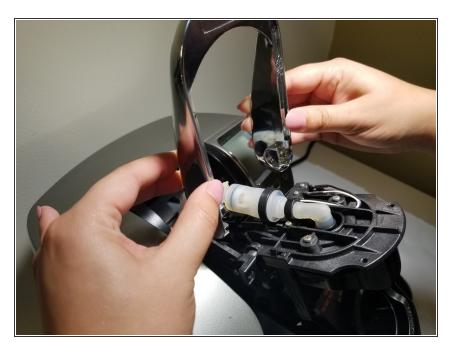
Step 4

Push the handle back and upward to detach it from the Keurig.

To reassemble your device, follow these instructions in reverse order.
