Vizio SmartCast Tablet Remote XR6P Micro USB

Charging Port Replacement

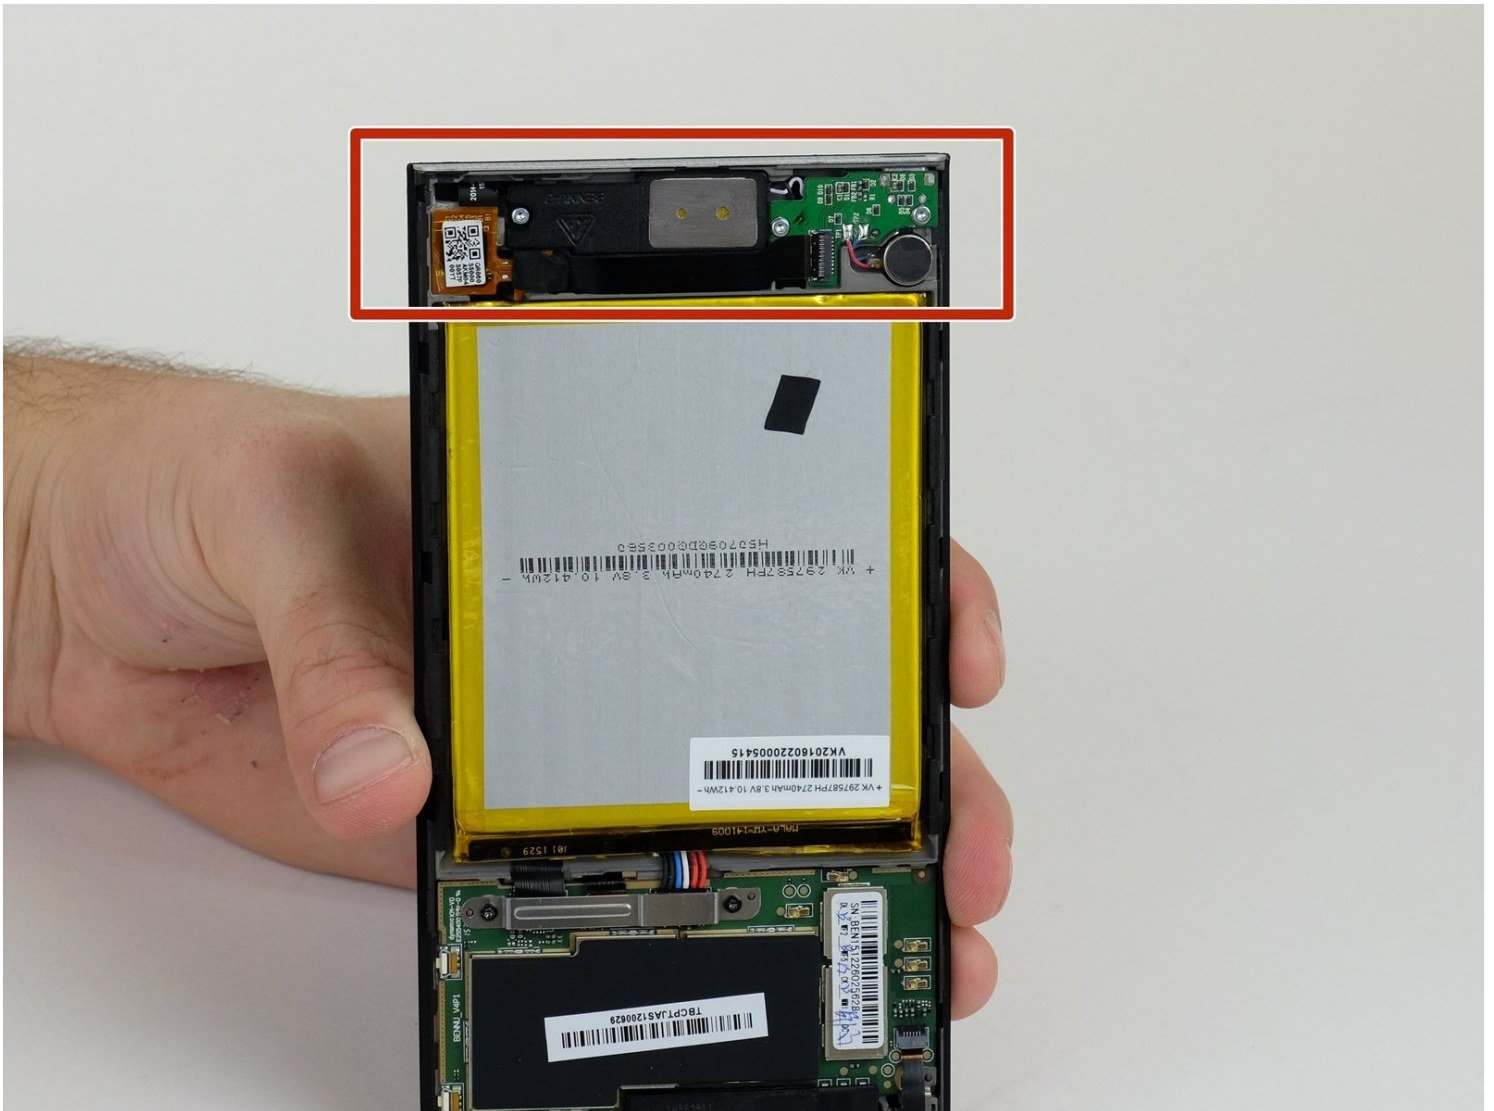
Over time, the Micro USB charging port may become worn out or defective. Here is a guide on how to replace this part. During step 1, take special care to the black ribbon as it can be easily damaged.

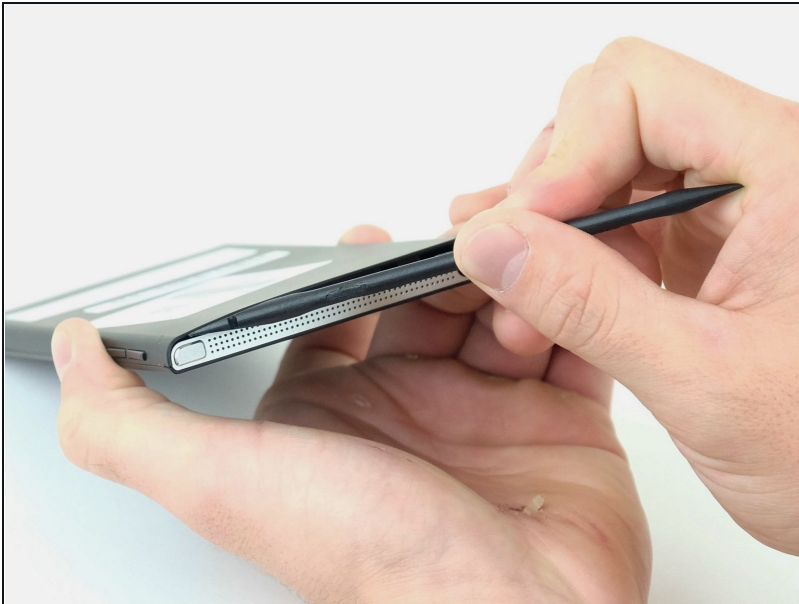
Step 1 — Back Cover

- Obtain the black plastic spudger tool from the iFixit toolkit. Position the device as shown in the picture. Insert the flat end of the spudger directly in the space above the power button between the back cover and front screen.

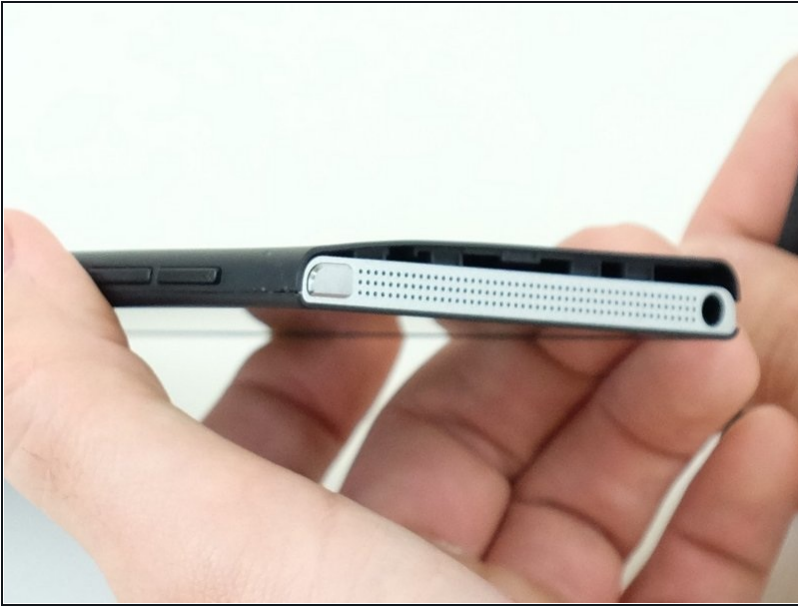
Step 2

- Gently pry up on the plate with the spudger. You may hear some cracking noises as you work the spudger around your device, this is normal.

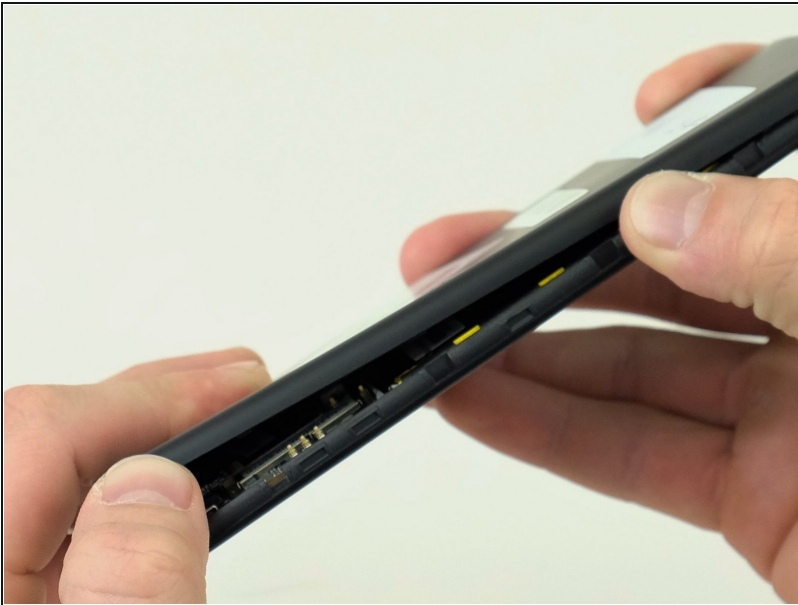
Step 3

- Pry around the edges of the tablet with your fingers until you have successfully removed the back of the device.

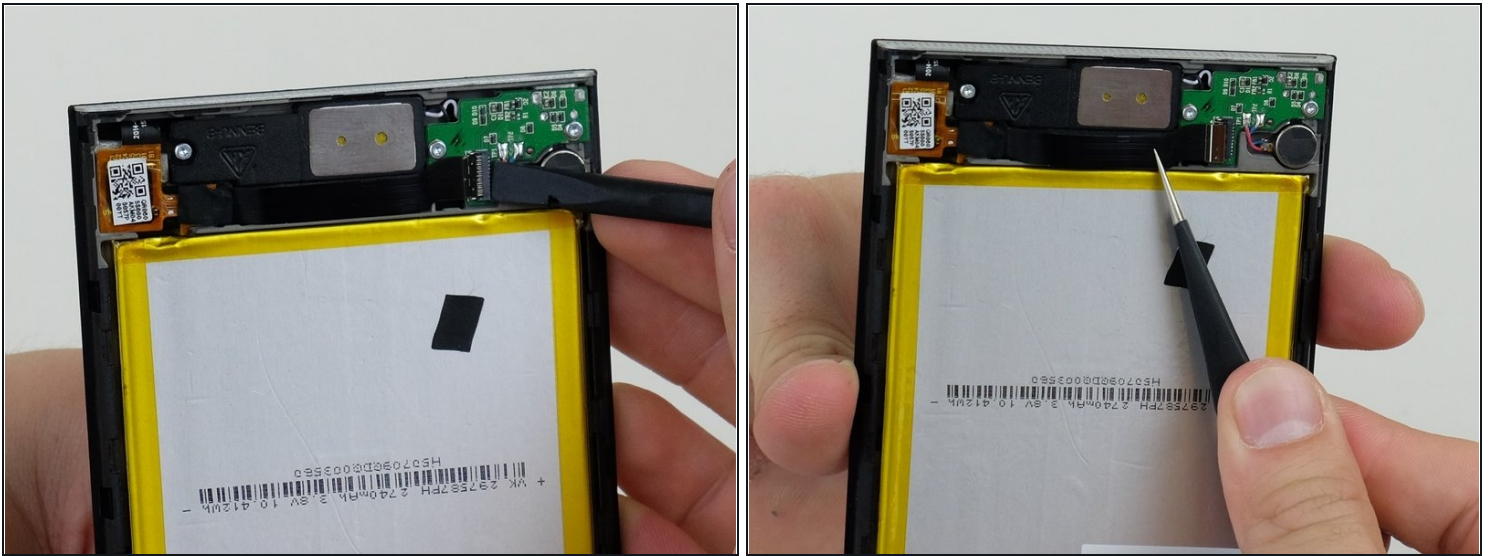
Step 4 — Micro USB Charging Port

⚠ The black ribbon can be easily damaged during this step, so proceed with caution.

- Place the flat end of the black plastic spudger under the black plug and pry up to release the black ribbon. Using the metal [tweezers](#), pull the black ribbon out of the plug.

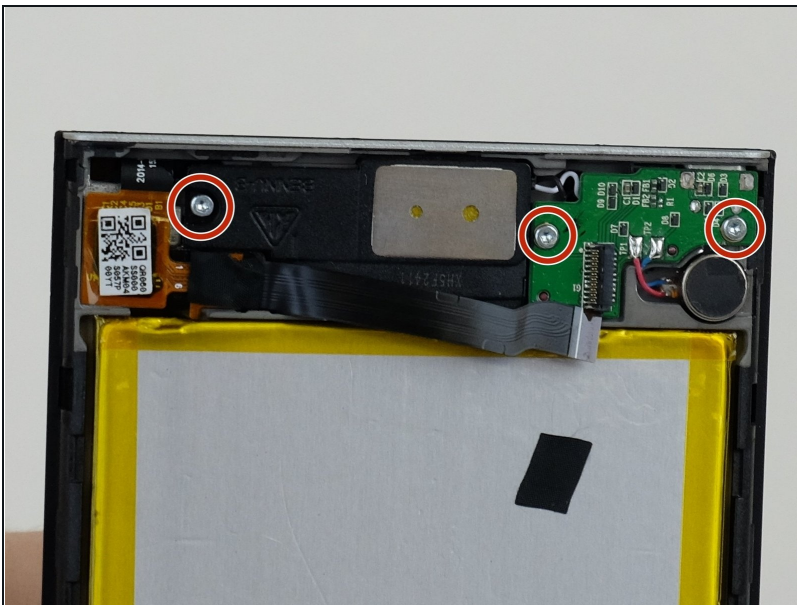
Step 5

- Remove all three 3mm-long silver screws using the T5 Torx screwdriver.

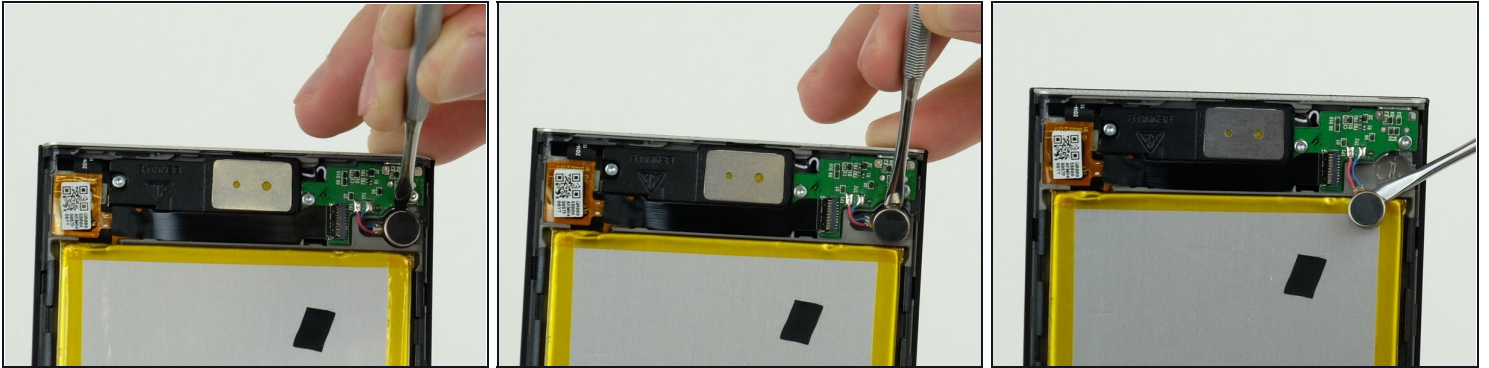
Step 6

- Place the shovel end of the metal spudger under the speaker and pry upwards to remove the speaker from the device.
- ① The speaker is secured to the device with adhesive glue so you may hear cracking noises while prying with the spudger.

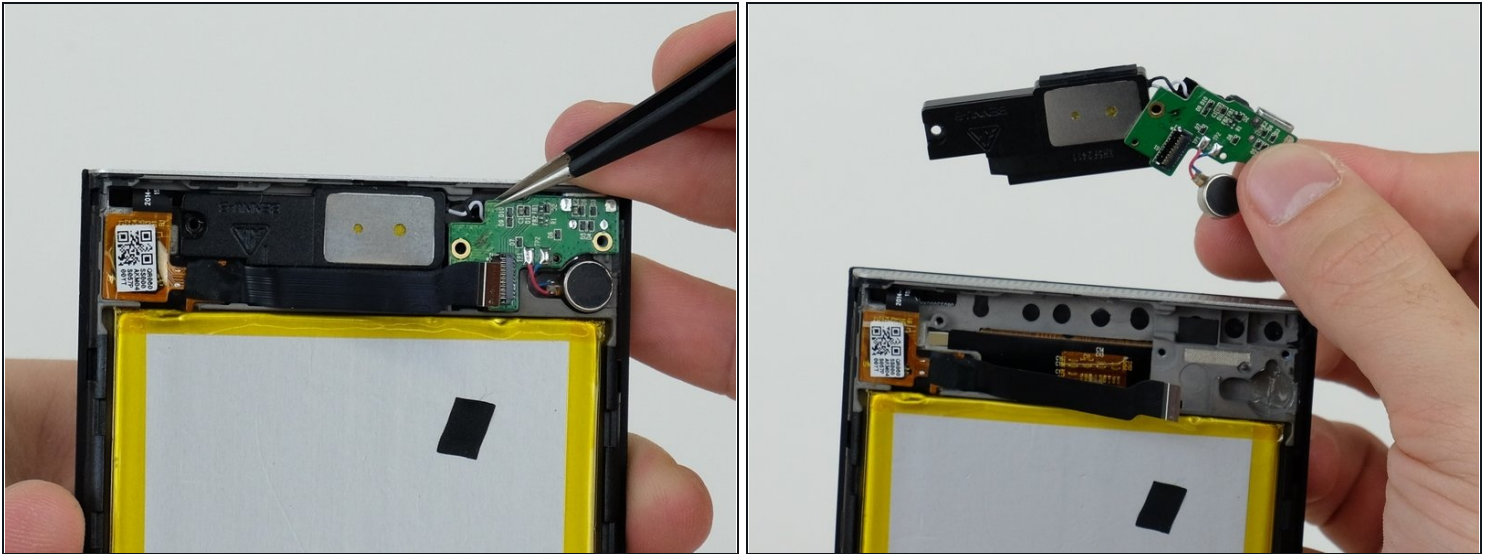
Step 7

- Using the tweezers, grab a hold of the Micro USB assembly and gently remove it from the device.

To reassemble your device, follow these instructions in reverse order.
