# Escort Passport 9500IX Button Board Replacement

This guide will help you with replacing your Escort Passport 9500IX button board.

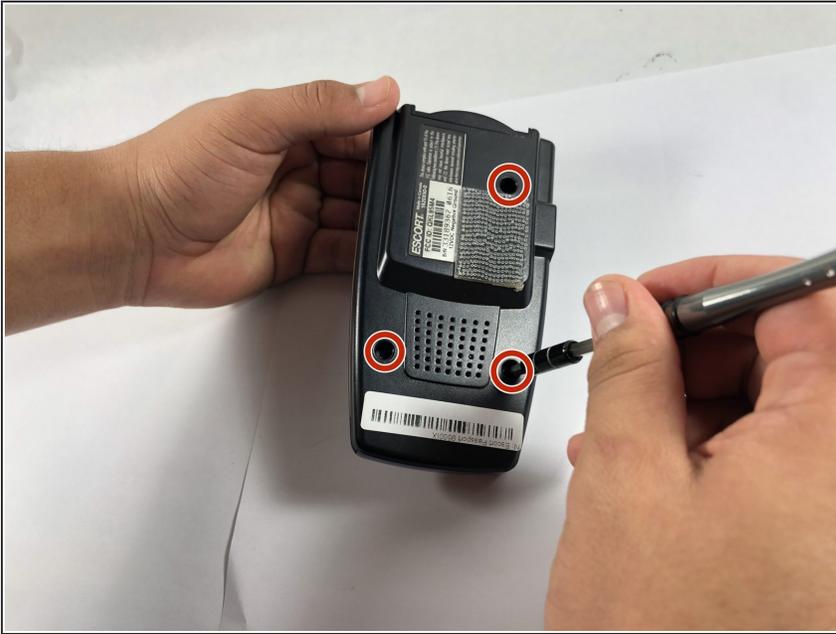
## Step 1 — Back Panel

- Remove the three 1.2 mm Phillips #1 screws on the back of the device.

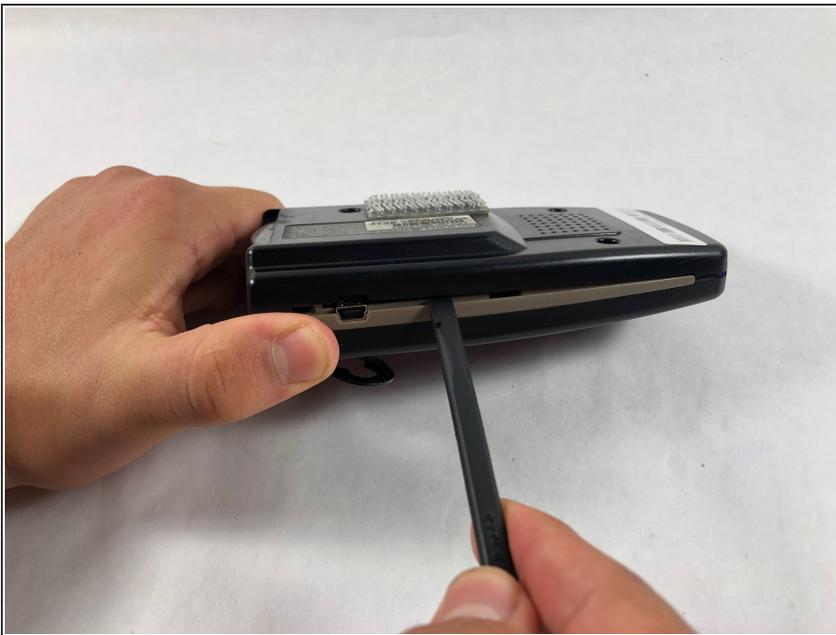
## Step 2

- Pry off the back panel of the radar using the nylon spudger.

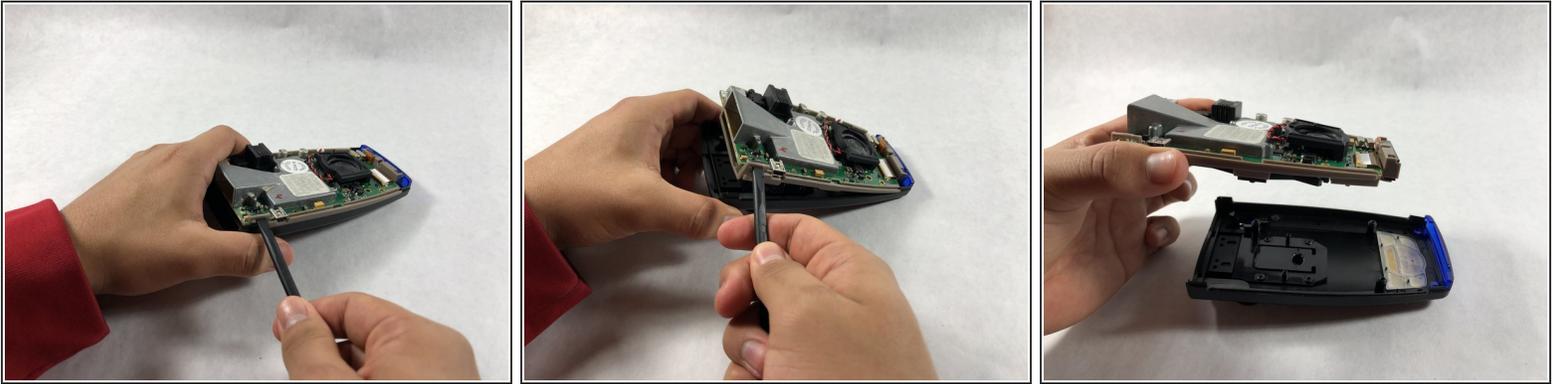
### Step 3 — Buttons

- Carefully pry the grey frame off the black plastic covering using the nylon spudger.

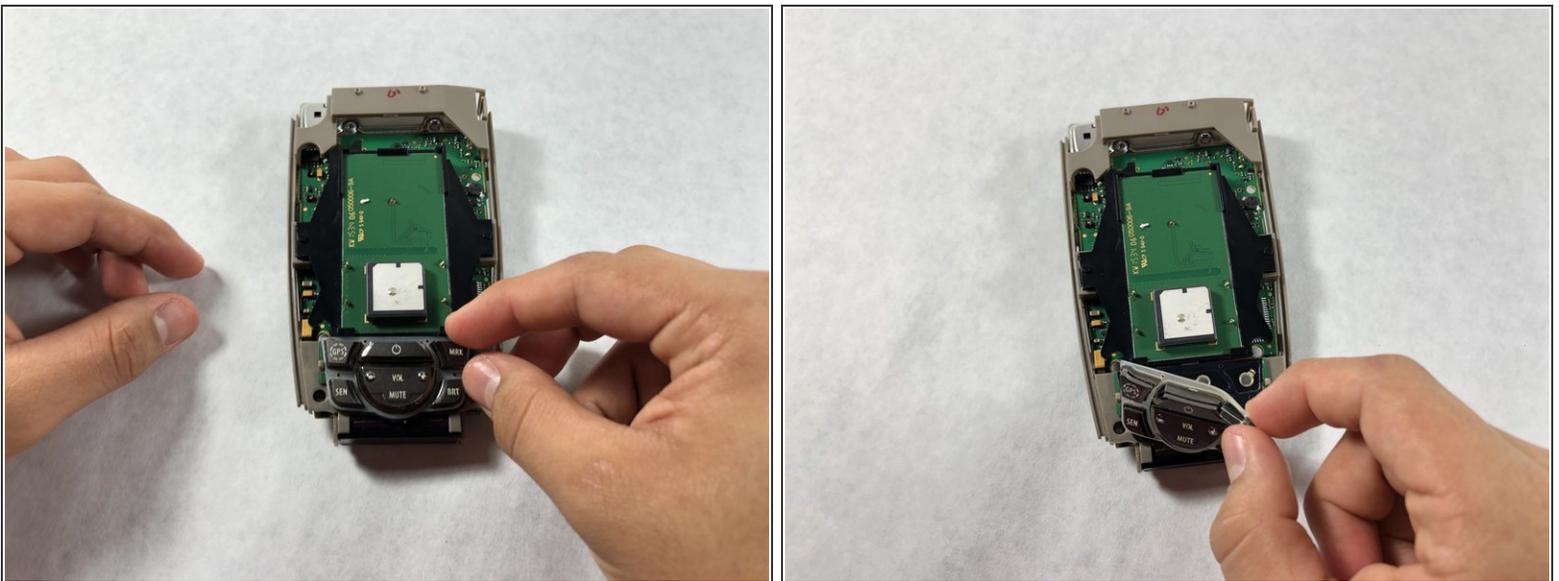
### Step 4

- Slowly peel the buttons off the button board.

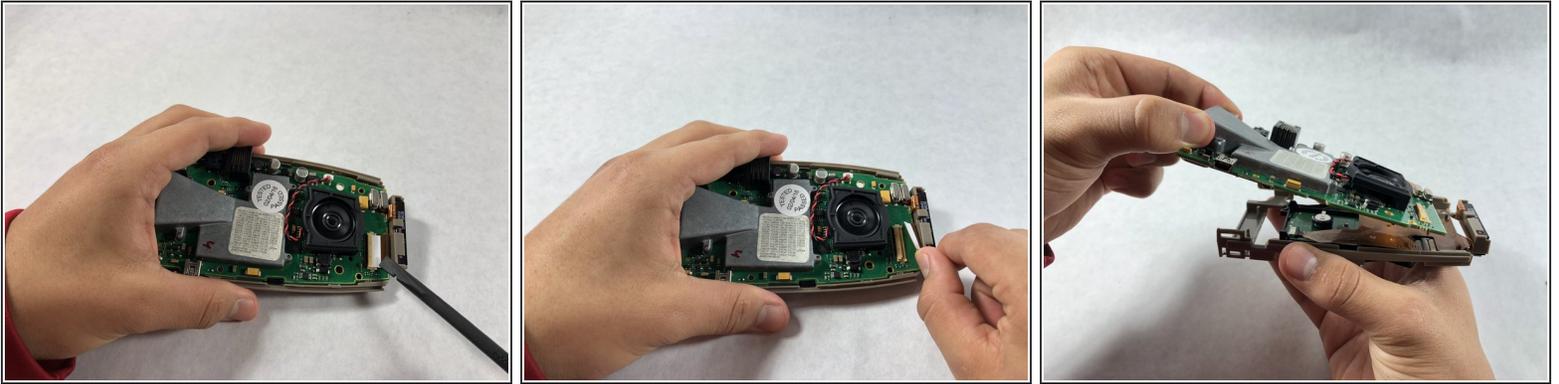
## Step 5 — Button Board

- Detach the orange flap on the motherboard.
- Carefully remove the motherboard from the grey plastic frame.

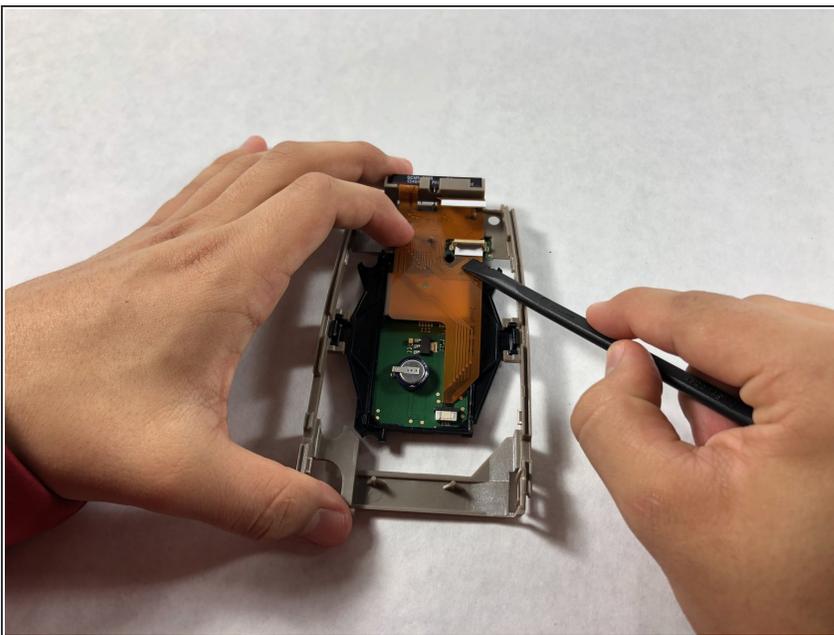
## Step 6

- Detach the orange flap directly behind the button board.

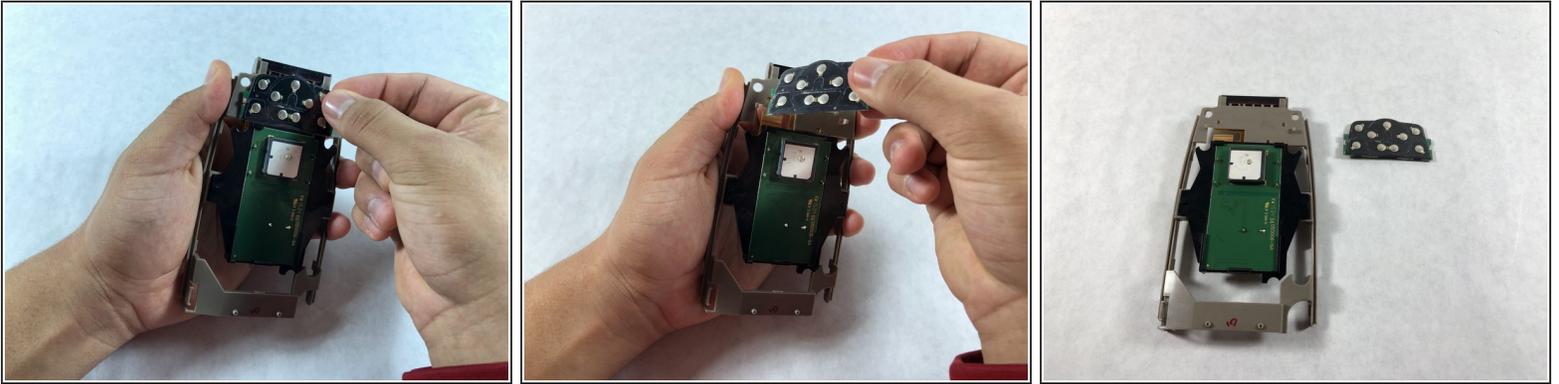
## Step 7

- Carefully pull out the button board from the grey frame.
