# Dell XPS 15 9575 Solid State Drive Replacement

Use this guide in order to replace or upgrade...

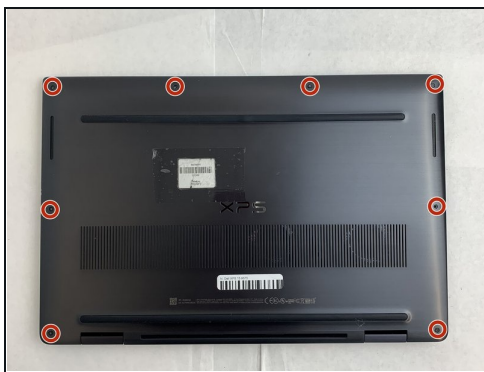
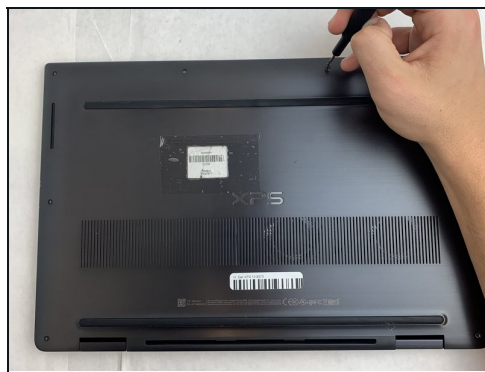
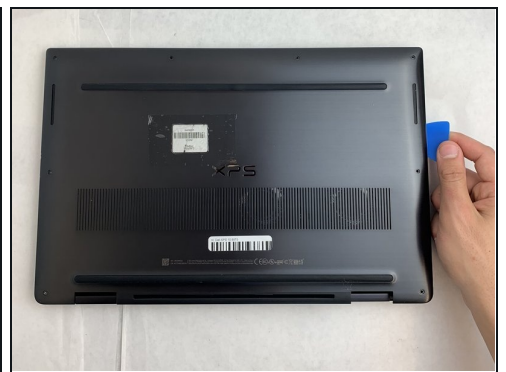
## Step 1 — Bottom Cover

- Use your T5 Torx driver to remove all eight 3.2mm hex screws holding down the back panel.
- Wedge an opening pick between the back cover and the base of the board, then slightly lift the tool to pop the clips on the back cover off.

**⚠ For your safety, please make sure the device is powered off and the A/C adapter is unplugged.**

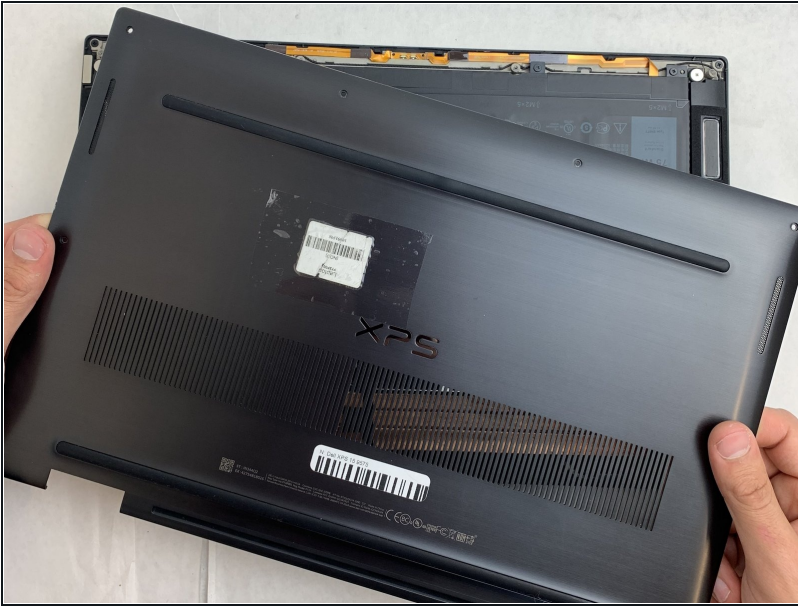
## Step 2

- Remove the bottom cover from the device when all sides are free.

⚠ Make sure all screws are removed before you lift the panel to prevent any damage from occurring.
