Xbox 360 E Button Board Replacement

Use this guide if your eject or power buttons are not working and need to be replaced.

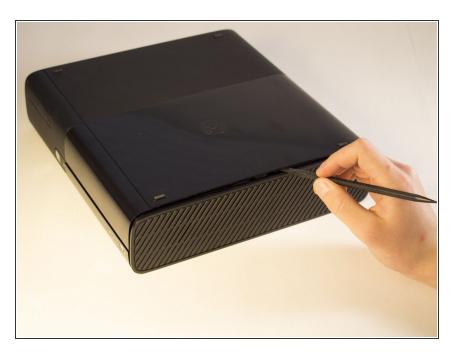
Step 1 — Top Panel

- Push the <u>Spudger</u> into the crevice between the grated top panel of the Xbox and the bottom body with the rubber feet.
- Pull back on the spudger like a lever, keeping it pressed firmly into the crevice.

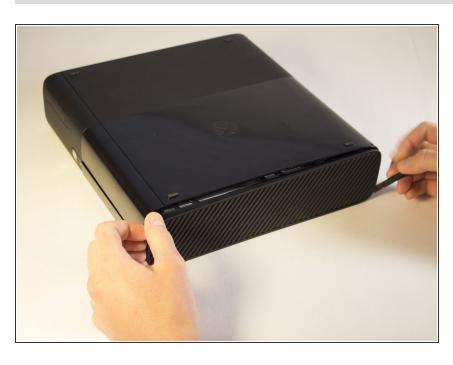
Step 2

- Slide the spudger along the separation you have created between the grated panel and the bottom body of the Xbox.
- Periodically pull back on the spudger like a lever, keeping it pressed firmly into the crevice.

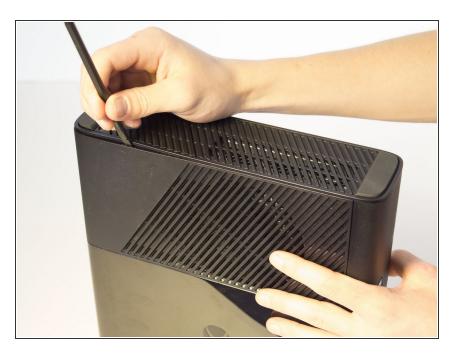
Step 4 — Bottom Panel

- Push the spudger into the crevice between the right grated face and the top body of the Xbox. It's easier to begin away from the vent.
- Pull up on the spudger like a lever, keeping it pressed firmly into the crevice.

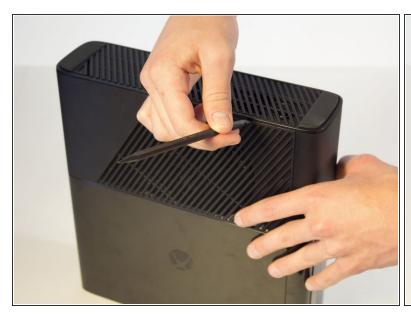
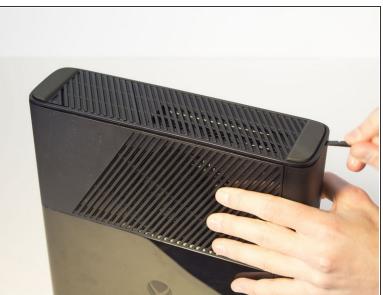
Slide the spudger along the crevice to separate the grated face and the top body.

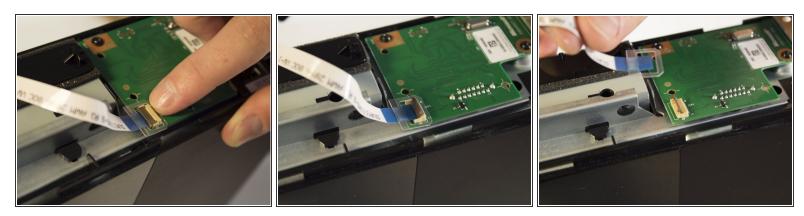
Step 12

• Find the brown section where the ribbon cable enters the green board. Flip the brown part up and pull out the plastic tab at the end of the ribbon.
