# Macintosh IIsx Hard Drive Replacement

## INTRODUCTION

The Macintosh IIsi Uses a 50-Pin SCSI Drive, that doesn't need to be terminated while in single configuration.

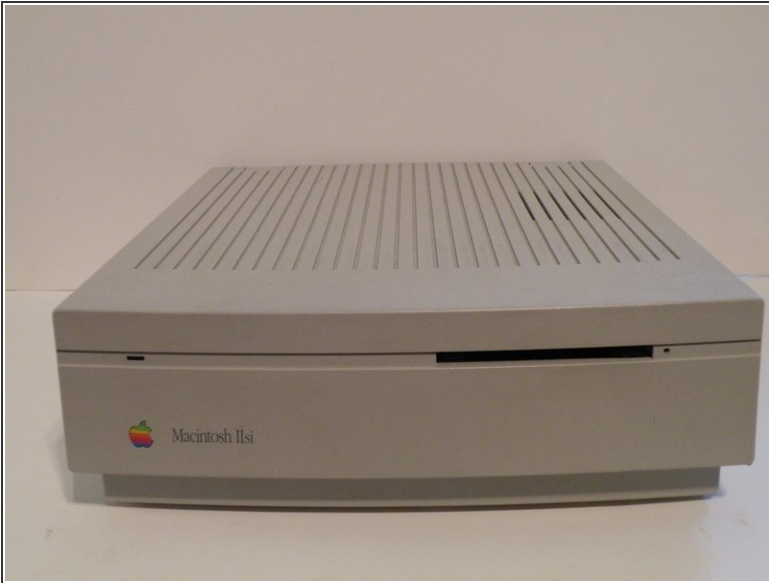
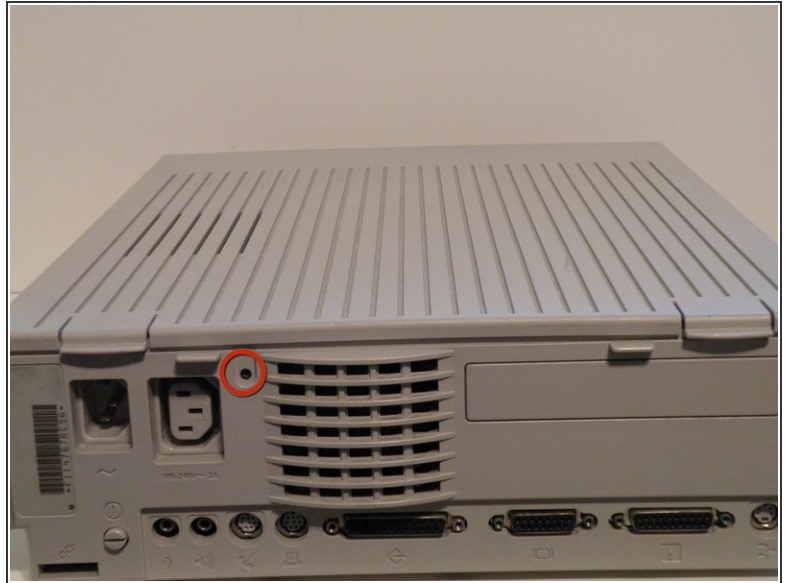
## Step 1 — Top Case

- Start by turning the computer around, and remove this #0 Phillips Screw.
- ⓘ There may or may not be a Phillips #0 screw here, depending on whether or not the computer has ever been serviced.

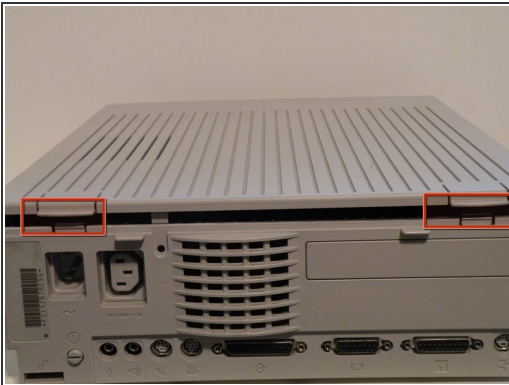
## Step 2

- Now lift these two clips, and slowly pivot the case up.
- You can now separate the top of the computer from the rest of the machine.

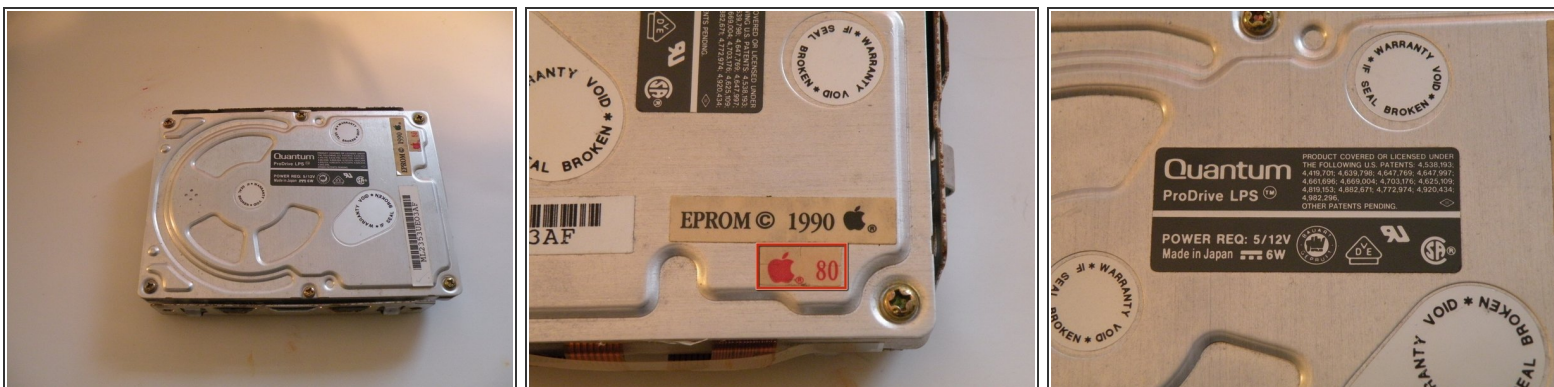
## Step 4

- The hard drive: A Quantum ProDrive LPS, made in 1990, and surprisingly, it still works!
- This drive has an 80MB capacity, not very large by today's standards, but not bad way back then...
- Believe it or not, hard drive construction hasn't changed much in the last 20 years. Other than a few new interfaces, the form factor, 3.5" width and 4-Pin 12V/5V power connector has stayed the same.

To reassemble your device, follow these instructions in reverse order.
