Xserve G5 CD Drive Replacement

Written By: alphaLONE

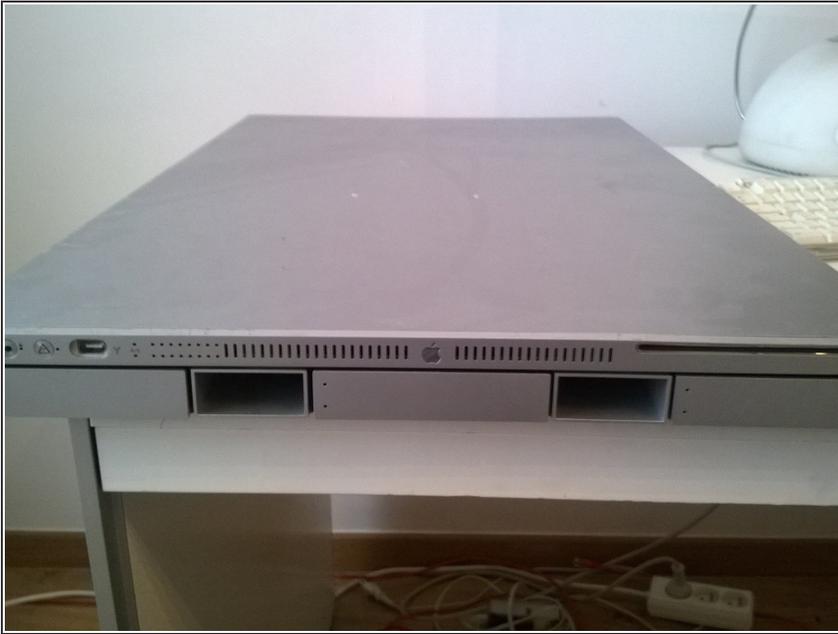
Step 1 — CD/DVD drive

- Here's my dead Xserve G5. I need a new power supply for it. So he will serve for the demo.

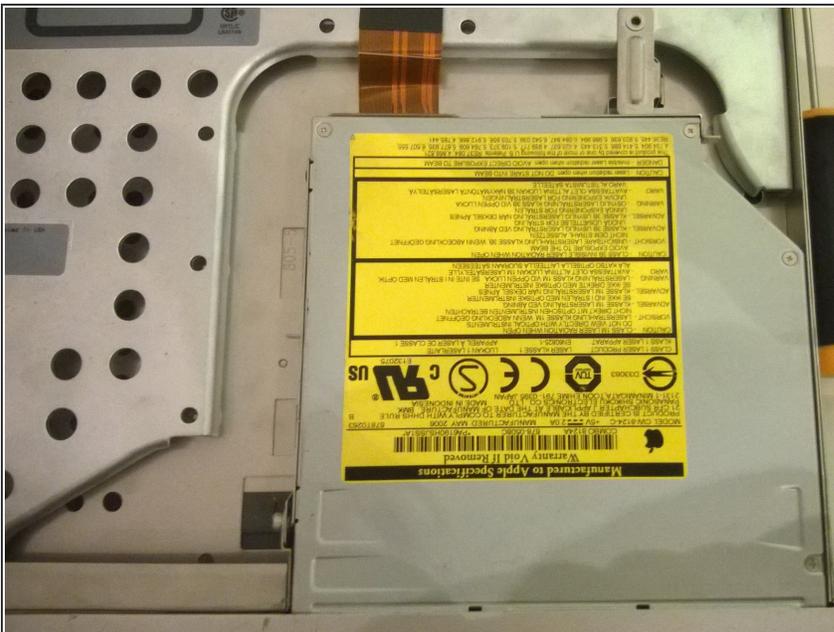
Step 4

- Hello little CD drive ! It's retirement time !
