# Disassembling Sony Vaio VGN-FW 590 Audio USB Board

A brief look at the steps to remove the bottom laptop cover of a Sony Vaio VGN-FW to get to the motherboard and replace a faulty Audio/USB Board (M760) or to simply blow out the dust from the fan and heatsinks.

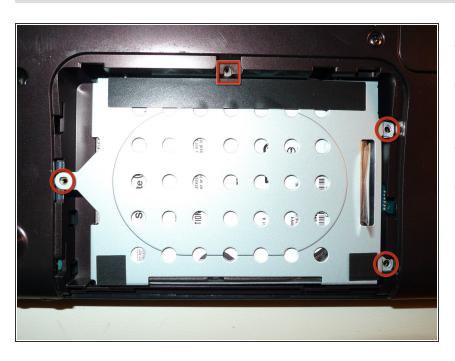
#### Step 1 — Audio USB Board

- Remove battery.
- Remove memory tray door (1 Screw).
- Remove hard drive door (1 Screw).
- Remove hard drive (3 Screws).

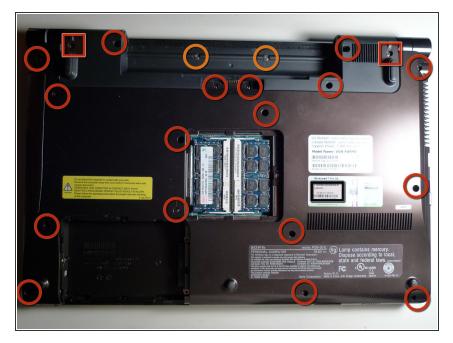
Remove all screws from the bottom cover. There are three types of screws. Marked here with Red Circles, Red Squares and Orange Circles.

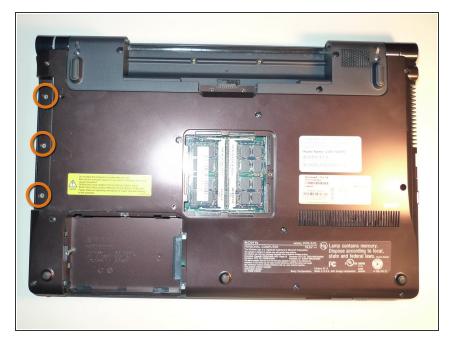
## Step 3

- Remove CD/DVD Drive by sliding it out.
- Remove three more screws, which were hiding under the DVD drive.

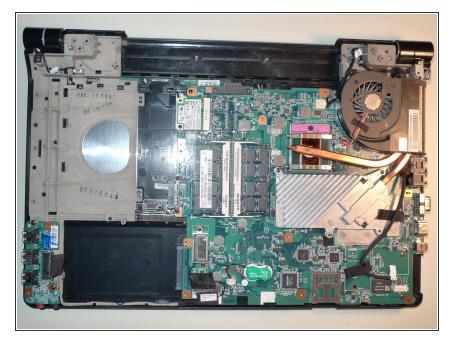
Carefully remove the cover, by unpopping it with a slim flathead, slide it out away from the RJ-45, HDMI and VGA ports.

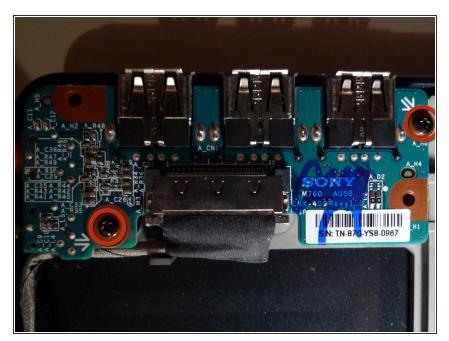
The audio/usb interface card is now within reach. Just remove the two screws and carefully slide out the flat connector to remove the card.

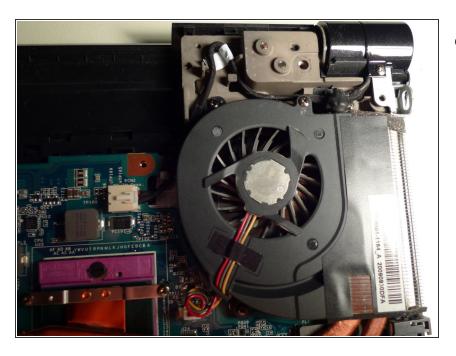
## Step 6

Fire up the air compressor and blow out dust from the fan and heatsinks.

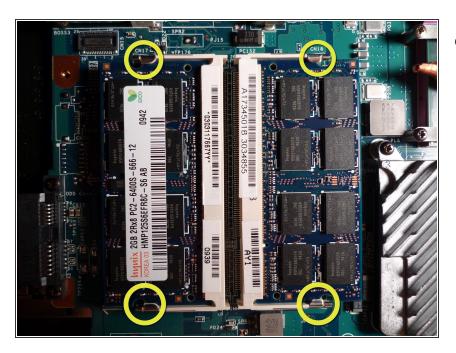
If you are replacing your RAM, simply unpop the four latches and slide out the memory sticks.
