Axess TA2513-10WT Side Button Replacement

This 8-step guide offers precise instructions for replacing the side buttons on the Axess TA2513-10WT Android tablet computer. It becomes essential when the side buttons become unresponsive due to extended use or get stuck, leading to operational difficulties. However, it's crucial to note that while the process carries little to no risk, there is a potential for harming the computer if the cover is removed too forcefully.

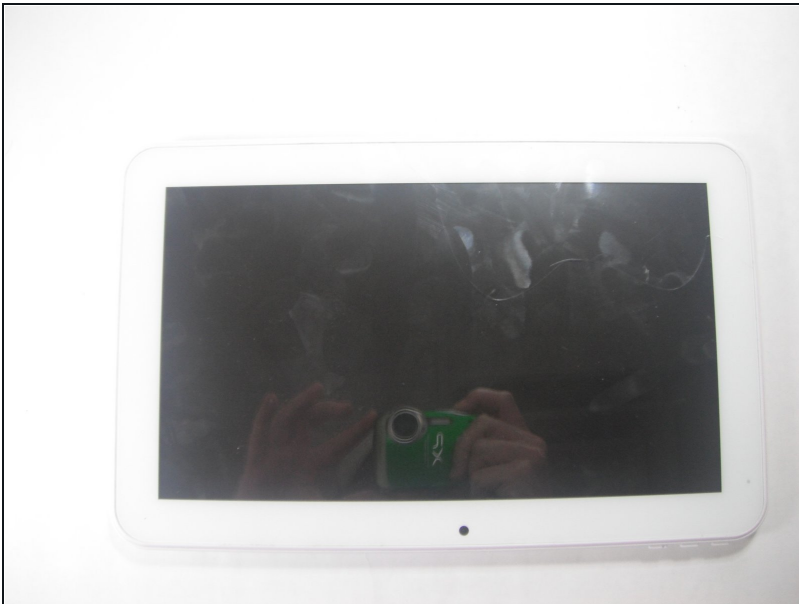
Step 1 — Back Cover

- Lay the tablet down on a flat surface with the screen facing up, and the external camera facing upwards and closest to you.

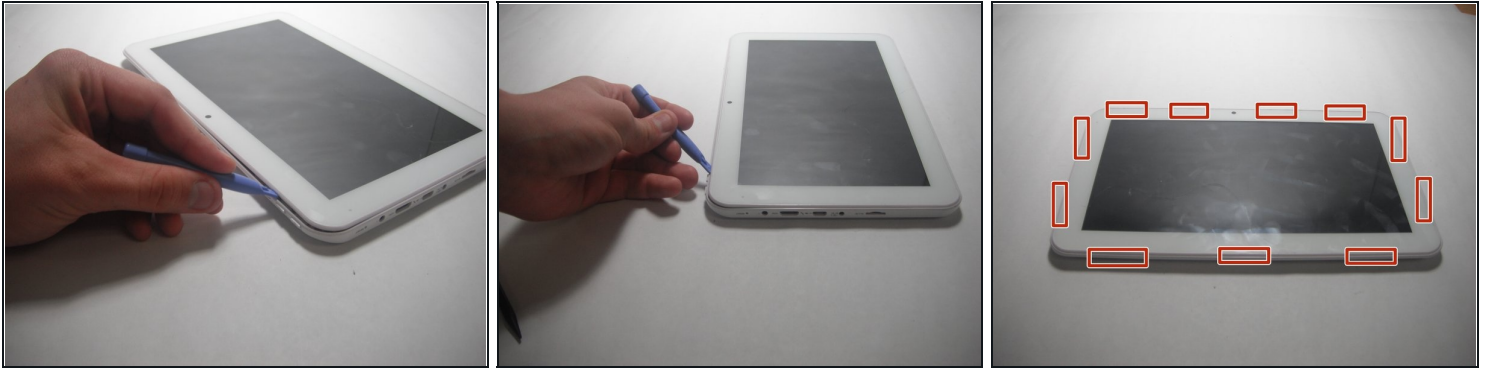
Step 2

- Insert the plastic opening tool in the space between the screen and the back cover above the volume buttons.
- Slide the plastic opening tool gently along the sides.
- ① If a small gap is not created between the screen and the back cover, pry gently upward at each of these latching points.

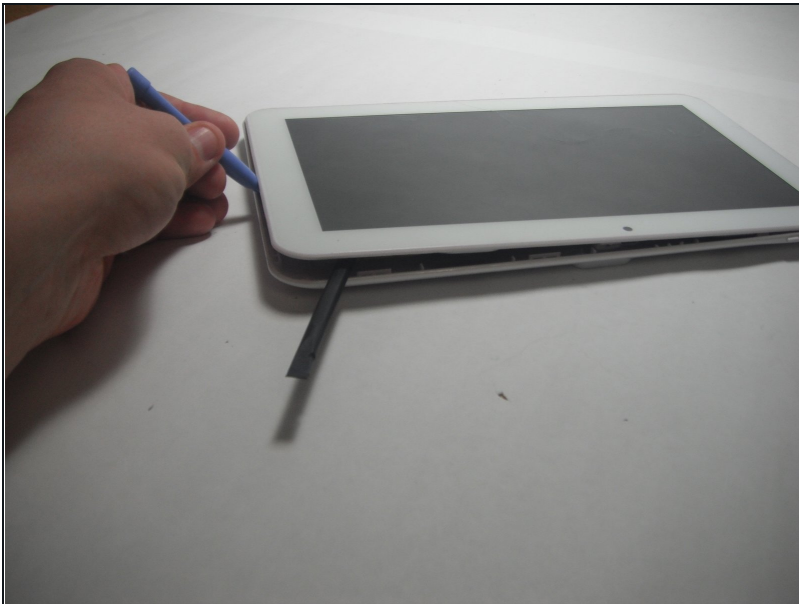
Step 3

- Place the spudger in an open space to keep the back case from shutting while you continue to slide the opening tool.

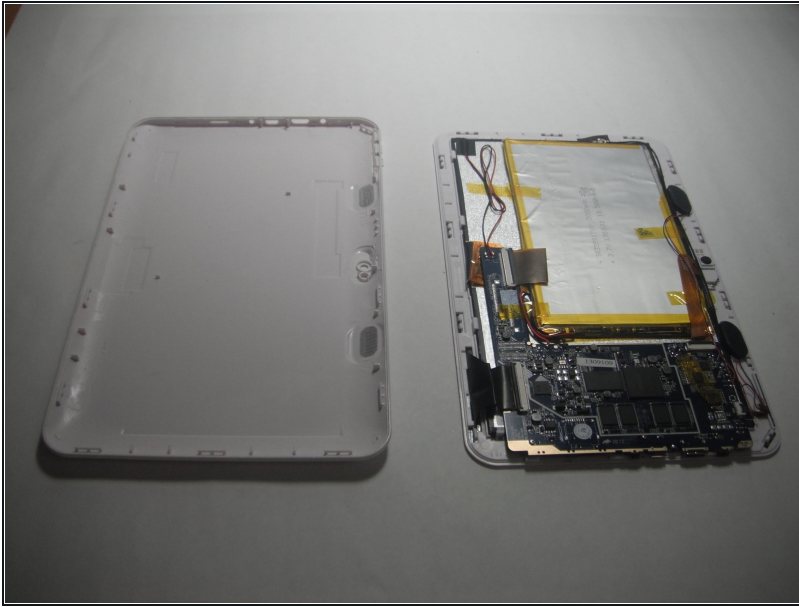
Step 4

- Remove the back cover with your hands once all points have been unlatched. It should separate completely from the screen that contains the battery and chip components.

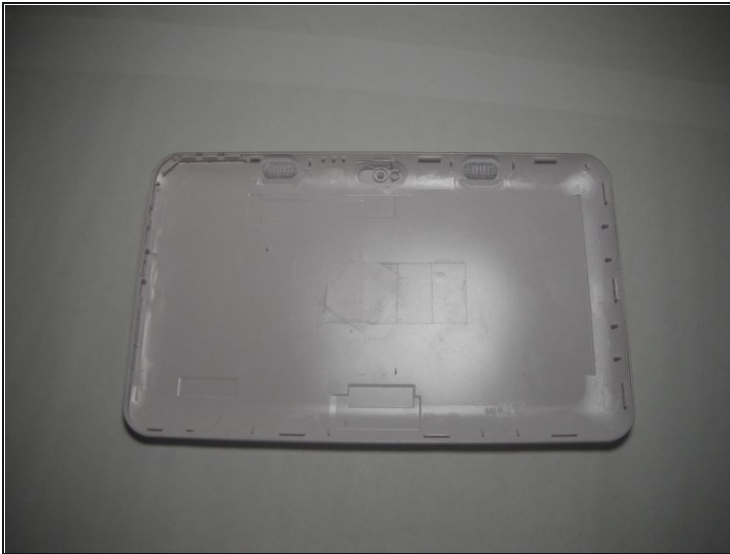
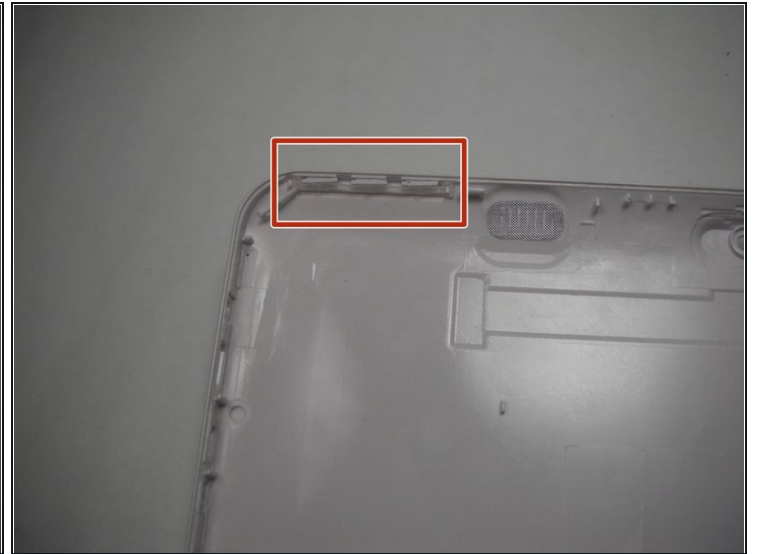
Step 5 — Buttons

- Orient the tablet's back cover so that the inside faces up and the buttons are positioned at the top left corner.

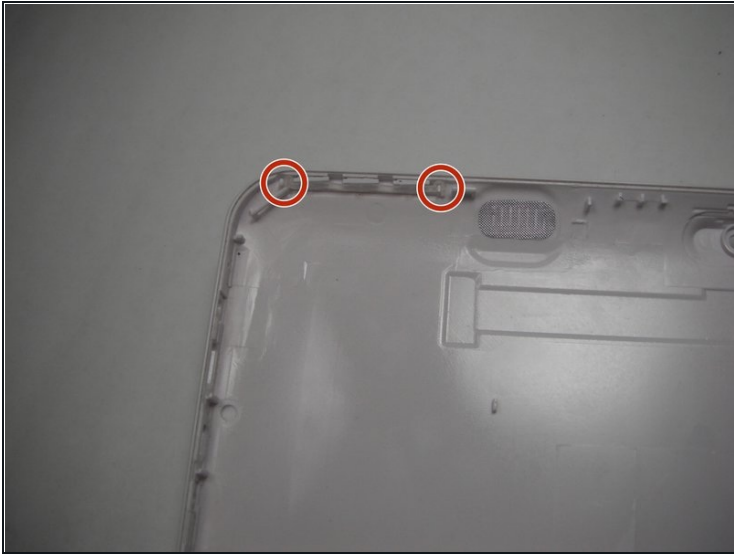
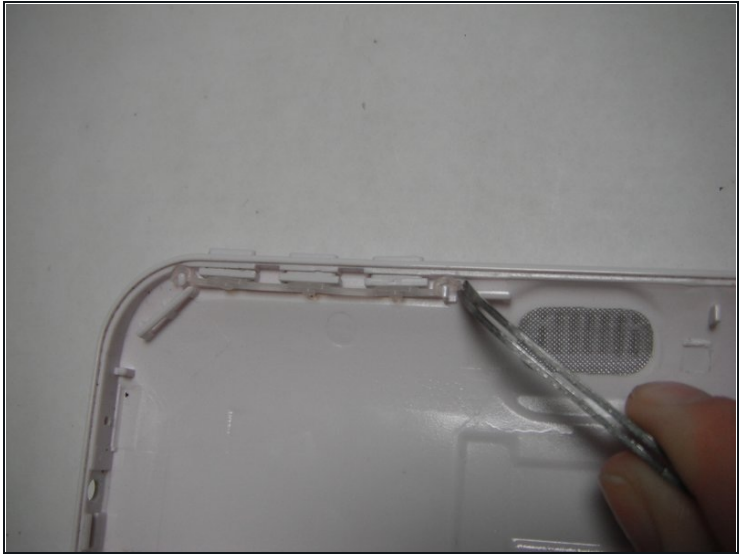
Step 6

- Unlatch the clear rubber holder from the posts with the tweezers.

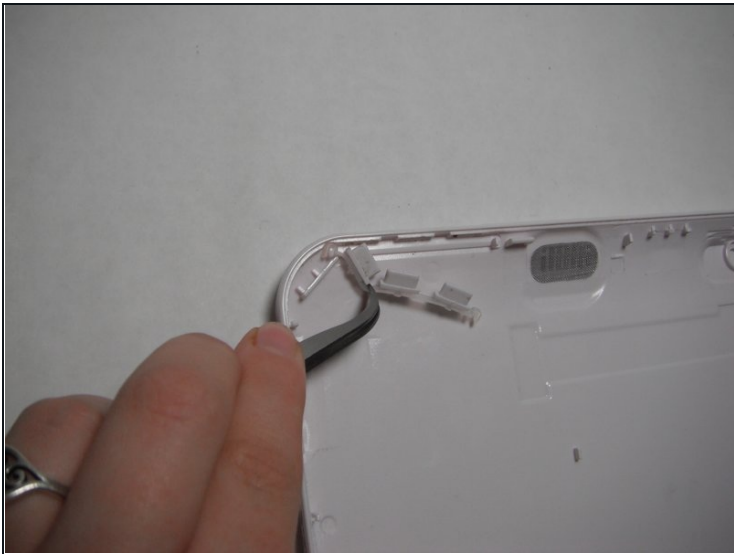
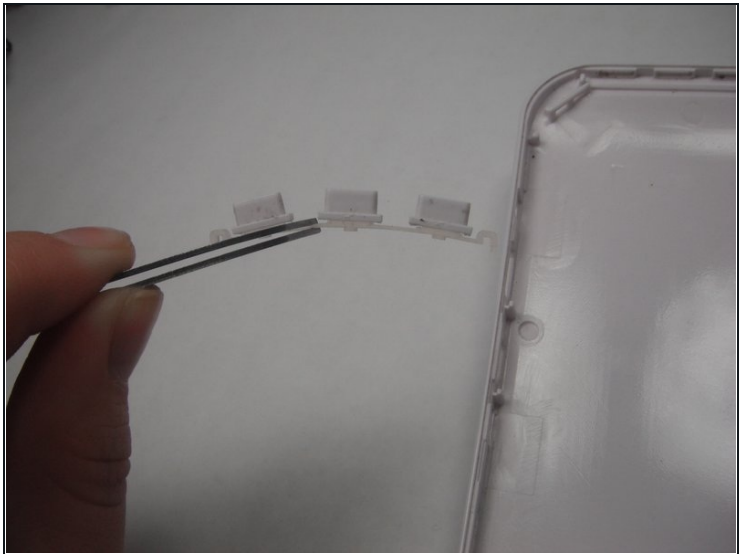
Step 7

- With tweezers, pull the rubber holder from the back cover completely.

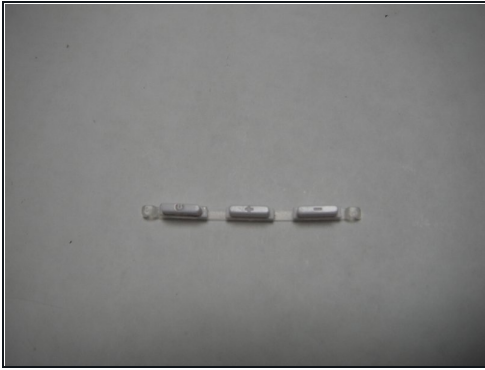
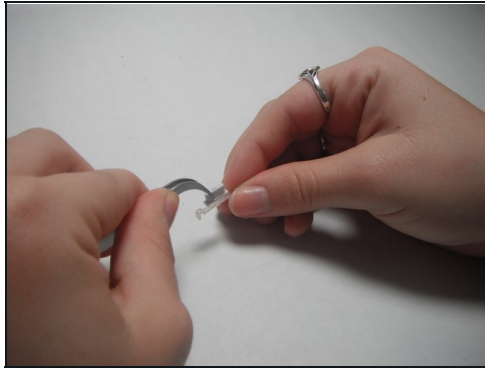
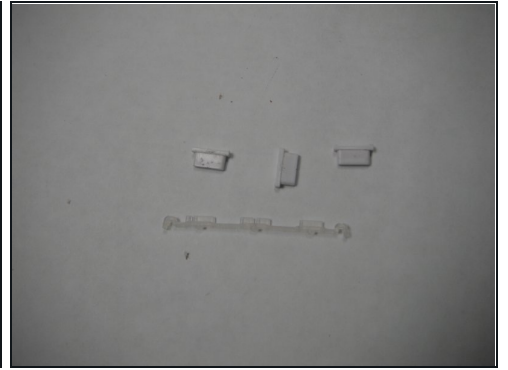
Step 8

- Remove the individual buttons with tweezers.
