Dell Chromebook 13-7310 Mousepad Replacement

The mouse pad on the Dell Chromebook 13-7310 is frozen or unresponsive.

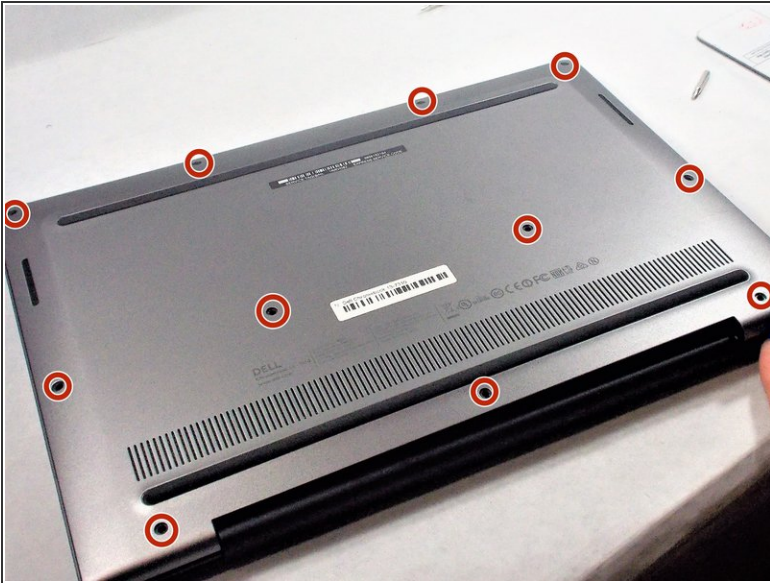
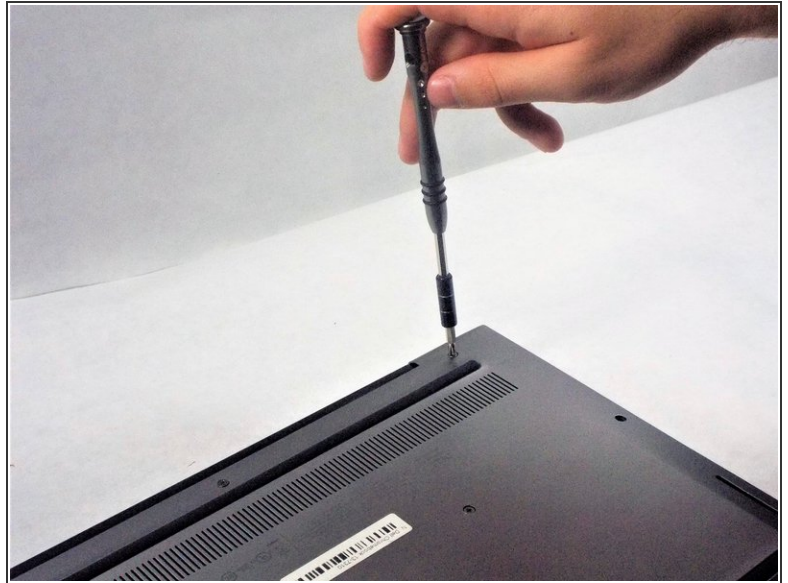
Step 1 — Back Cover

- Remove the eleven 3mm Phillips #1 screws.

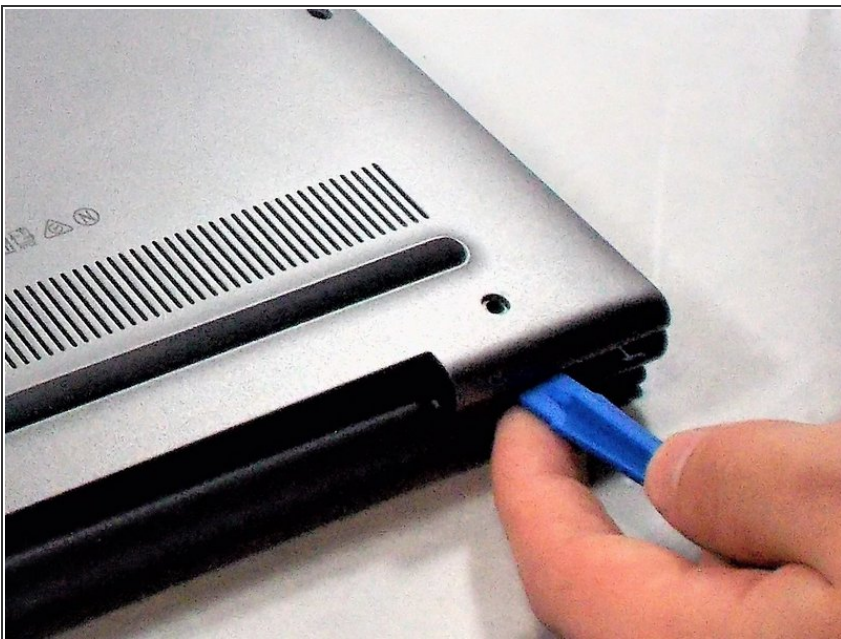
Step 2

- Use a plastic opening tool to gently remove the back panel.
- ⓘ It can be easier to pry open near a corner.

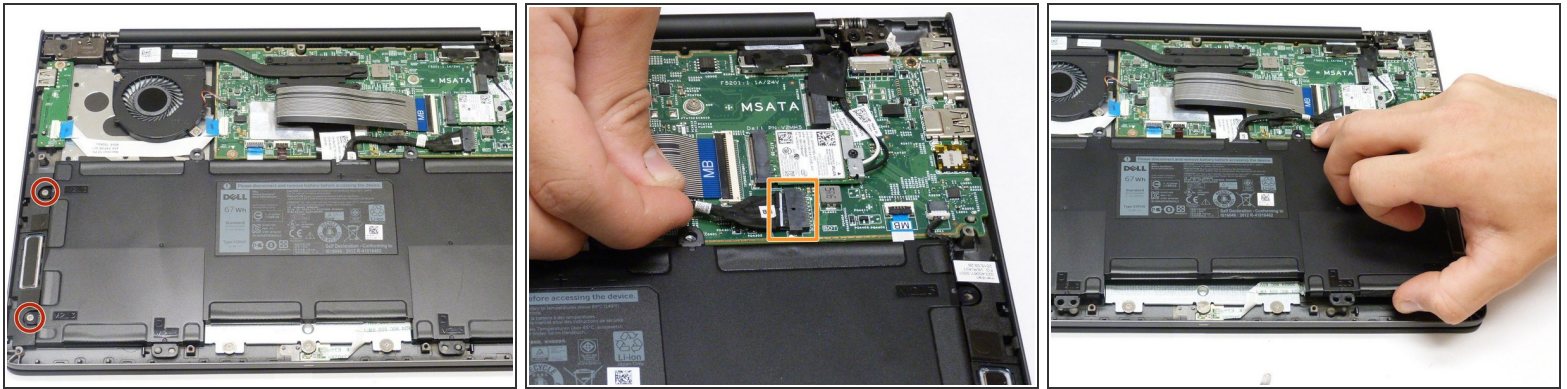
Step 3 — Mousepad

- The battery must be removed to access the mouse pad. To remove the battery, undo the two, 2mm screws located on each side.
- Once all four screws are removed, unplug the battery connection cable by hand to disconnect the battery from the motherboard.
- To remove the battery, lift up on one side to get your fingers underneath and lift away.

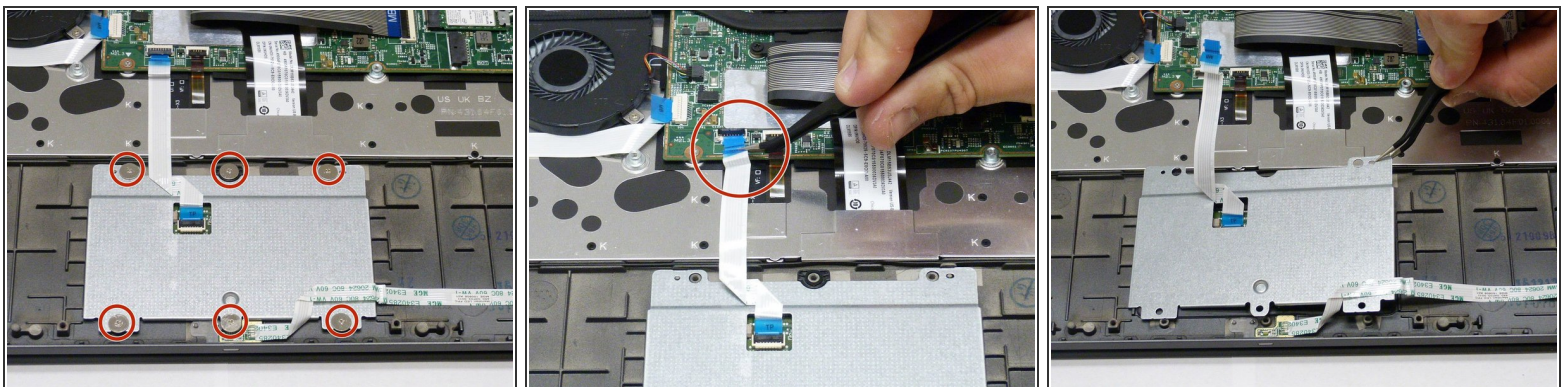
Step 4

- Remove the six 2mm screws located around the mouse pad cover.
- Using either fingernails or tweezers, lift the black cover on the ribbon cable and pull the cable loose from the motherboard.
- Once the ribbon cable is disconnected, lift up on the back cover to remove it and expose the mouse pad.

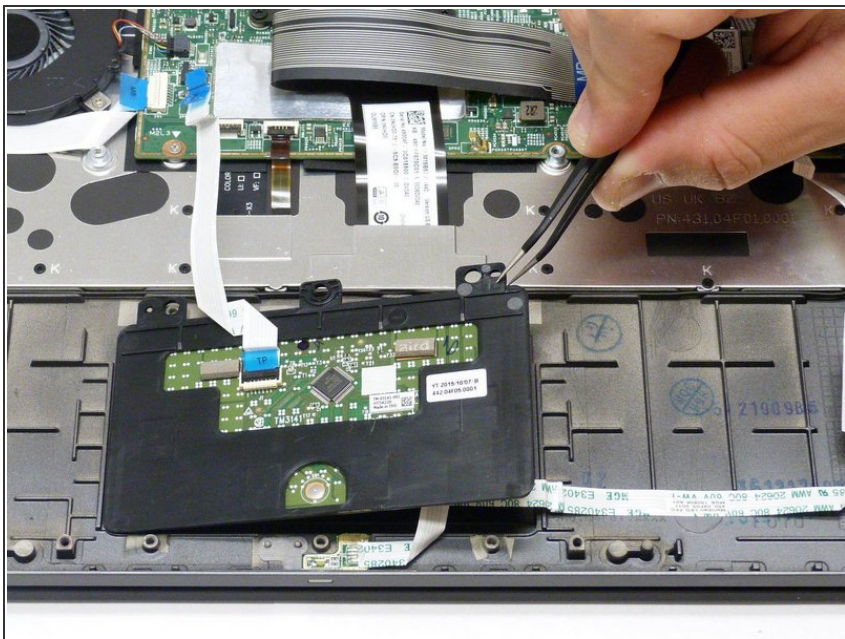
Step 5

- Now that the mouse pad is exposed, lift the assembly to remove the mouse pad.
